Trace Inspections

Property Location: 189 Sleigh Bells Court Nashville TN 37013

INSPECTION REPORT

Date of Inspection: 12/1/2021

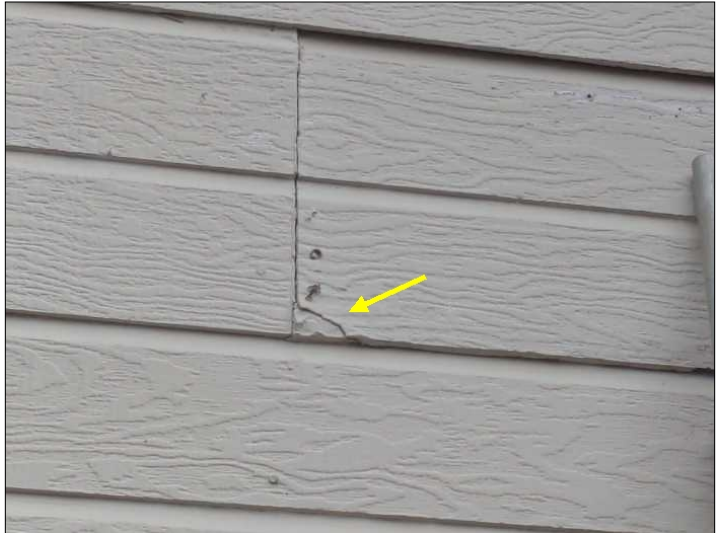
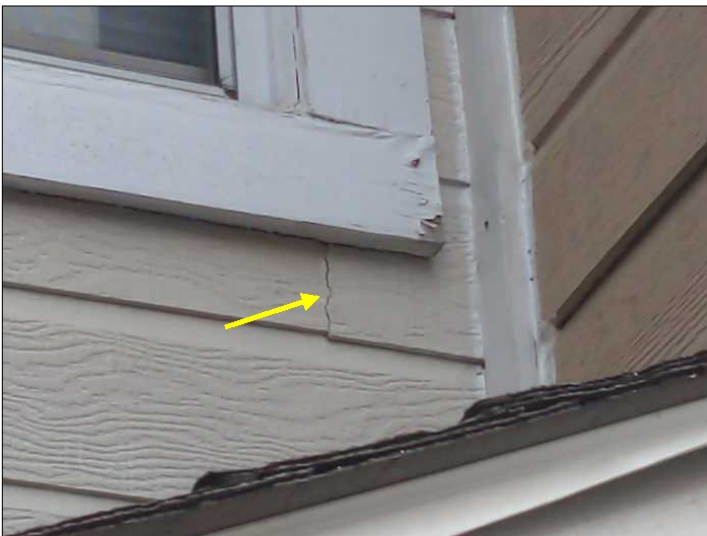
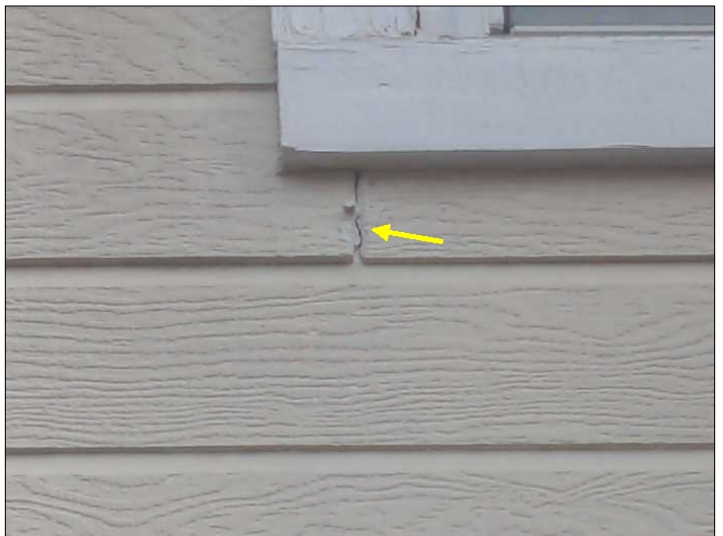
- Cracking and exposed nails in cladding on right side of home

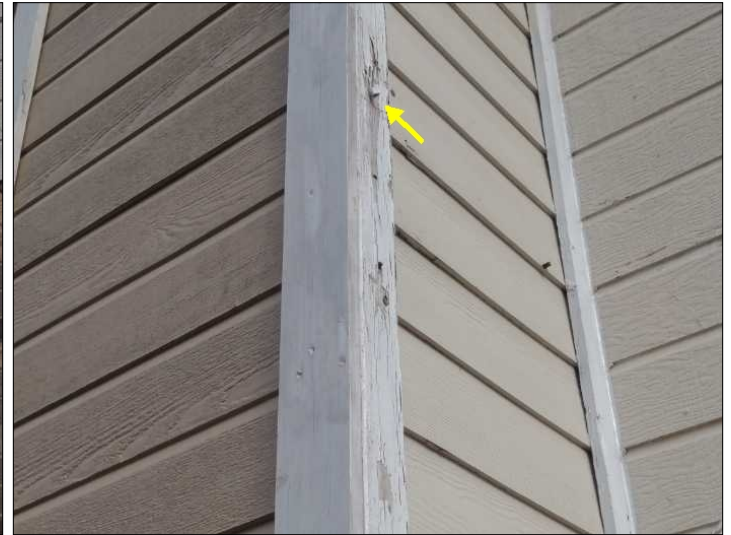
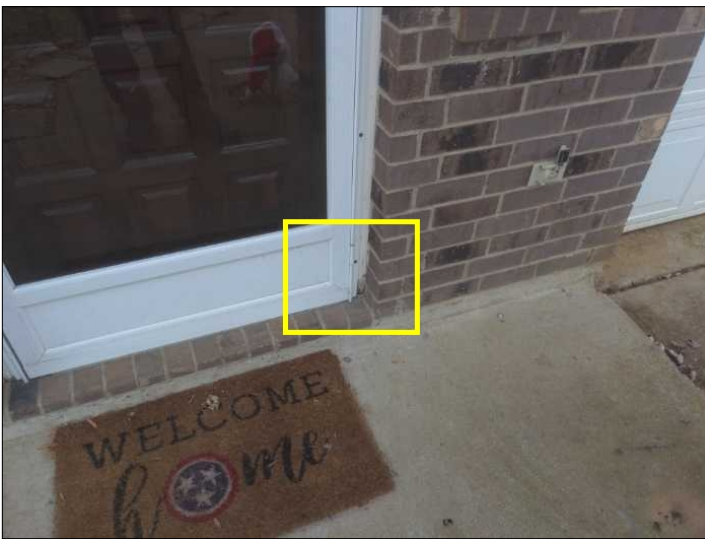
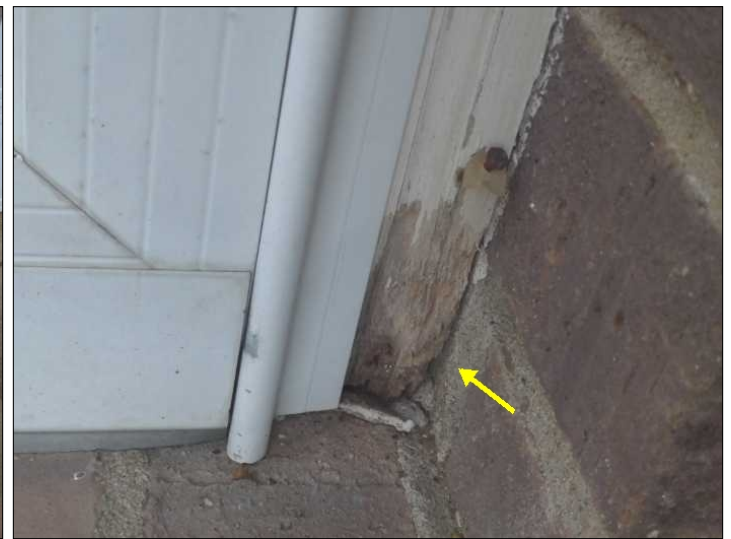
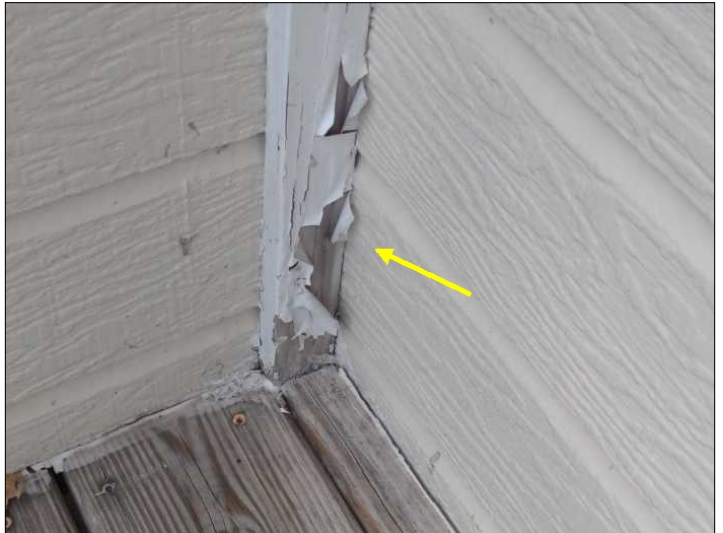
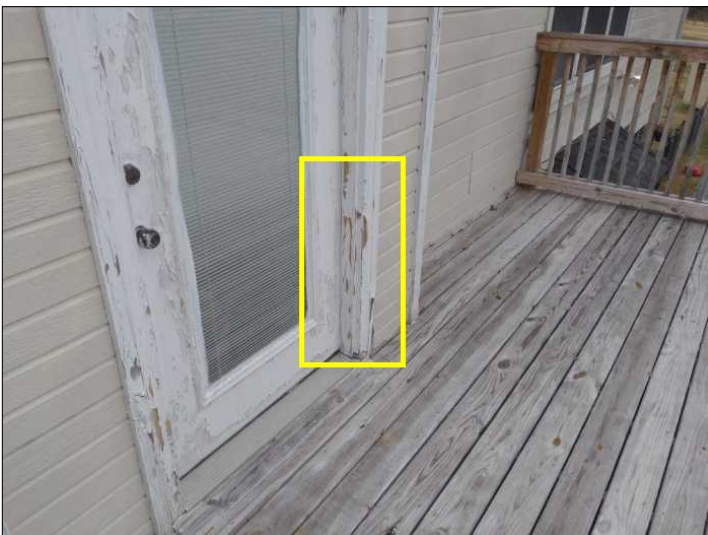
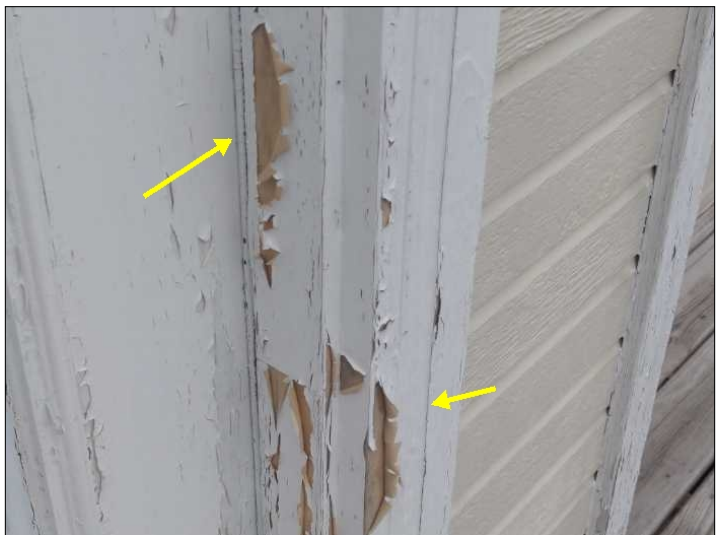
- The wood trim around several of the windows is rotting. All rotted wood should be properly replaced, this might even involve replacement of the entire window and frame.
- The trim at the base of the door is rotting and should be repaired.
- The wood trim is in need of paint. Paint helps to protect and extend the life of the wood.

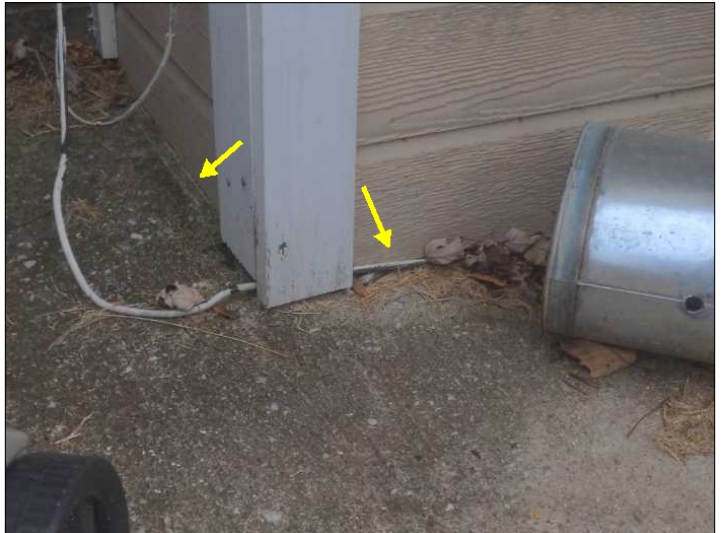
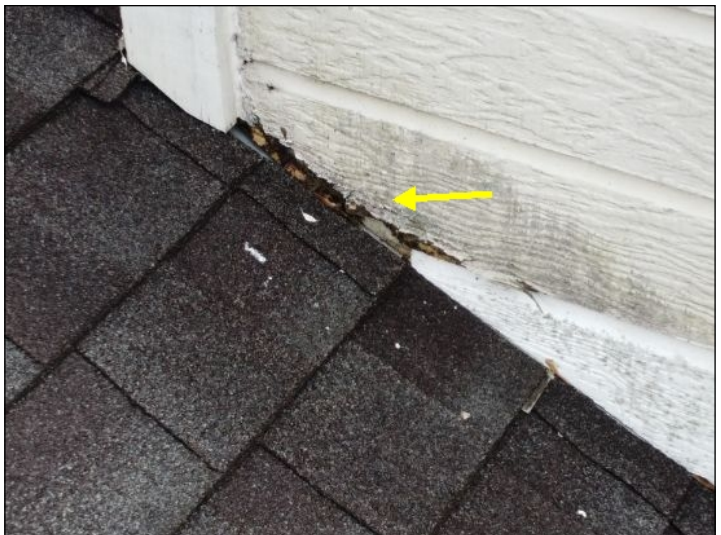
- The cladding does not have enough clearance between its base and the ground or grade. With wood siding we want to see around 6" to 8" of clearance and other types of cladding around 4". You should lower the bedding material or dirt or have the siding raised so that it is a minimum of 4" above the grade (ground).
- Moisture damaged cladding viewed on chimney chase.

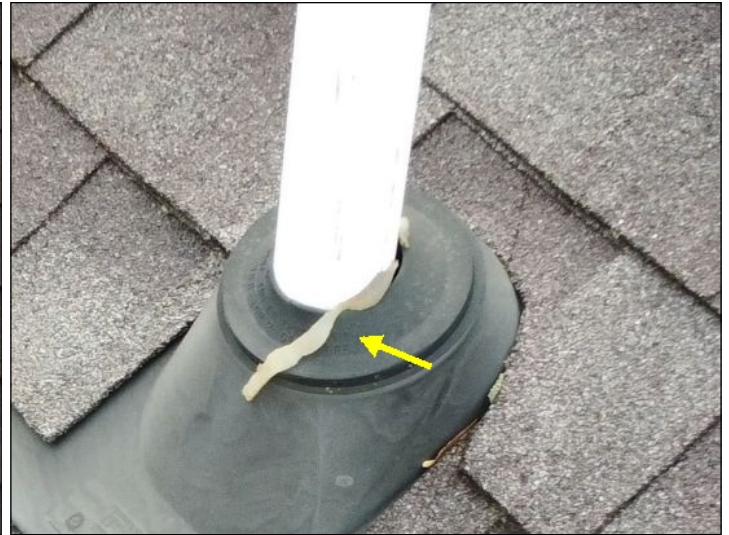
- The rubber boots around the vent stacks are cracking and need replacing. Recommend replacing all vent boots with new ones. Vent boots have a short life span of 5-7 years before they need to be replaced. Have a qualified roofing contractor make the needed repairs.

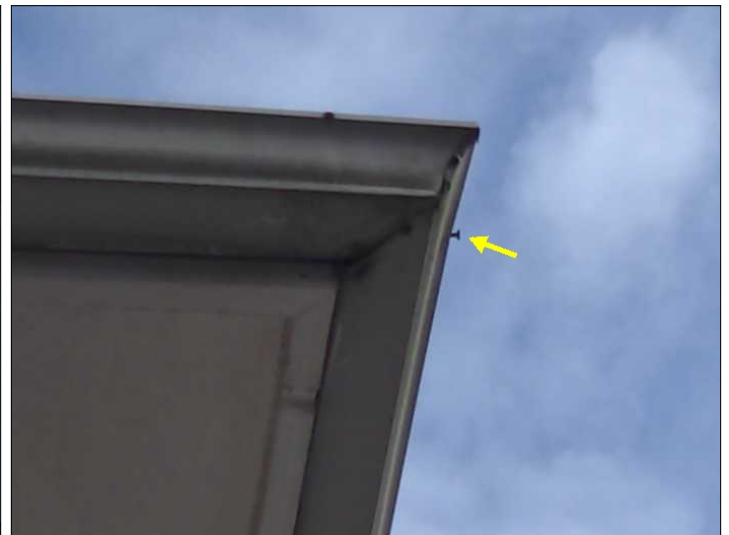
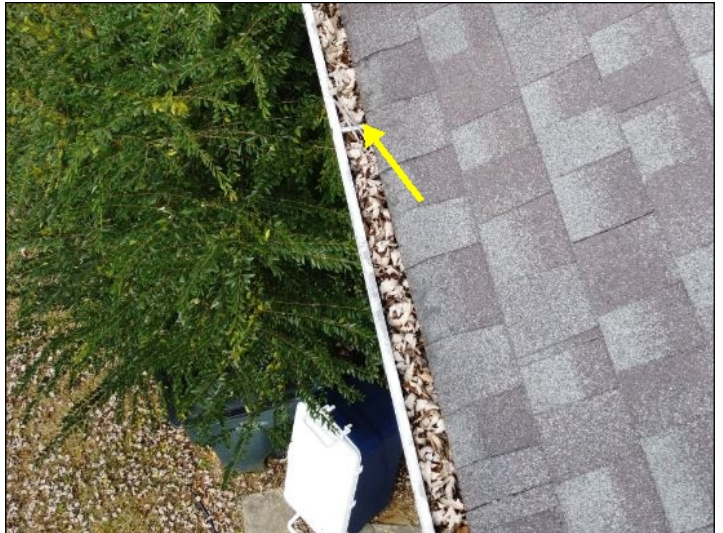
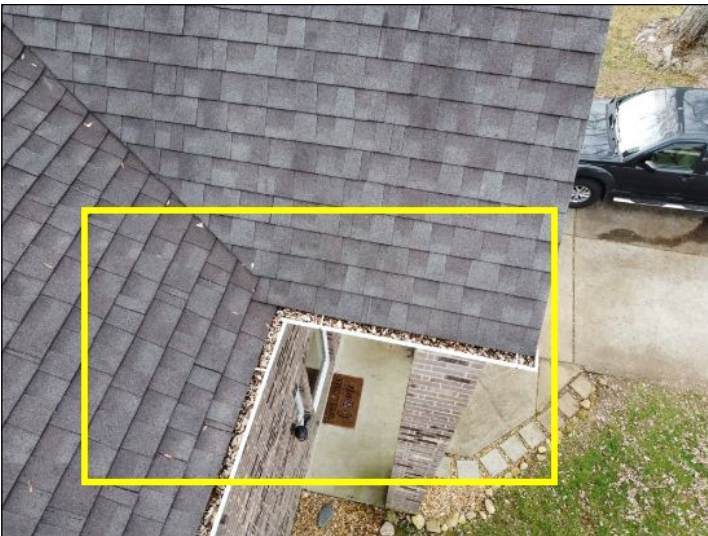
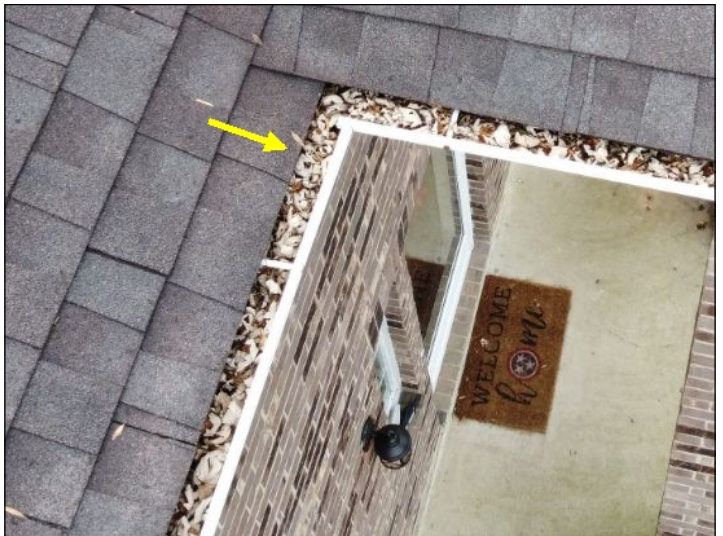
- Subsurface drains noted but they were not tested for blockages or proper drainage as this is outside the scope of a home inspection.
- Debris (sticks, dead leaves, etc.) in gutter, gutters need to be cleaned.
- The old "gutter nails" are pulling out from the fascia boards and this can cause the gutters to sag and not drain properly. Have the proper repairs made by a gutter contractor or roofing contractor that works on gutters.

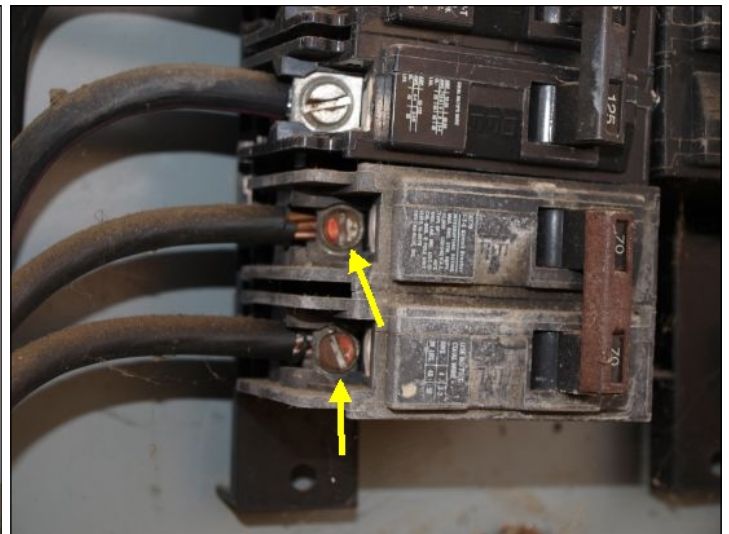
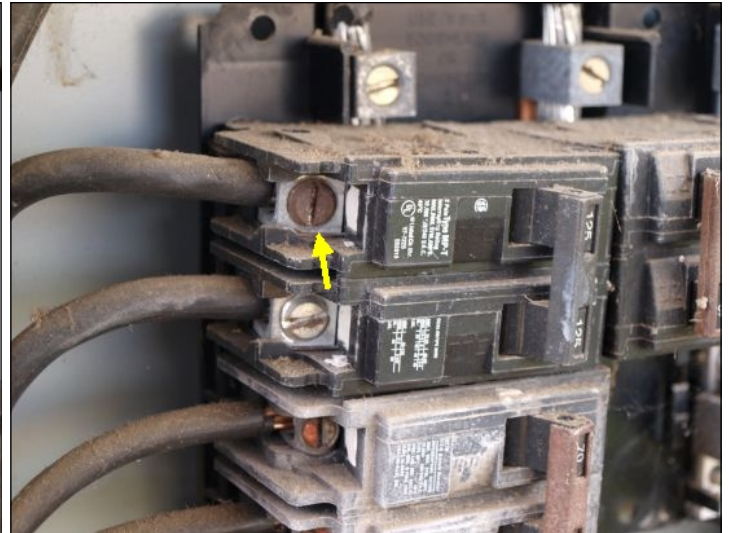
- Corrosion is noted within the electrical panel. This is an indication of an aged panel and is due to exposure to the elements.

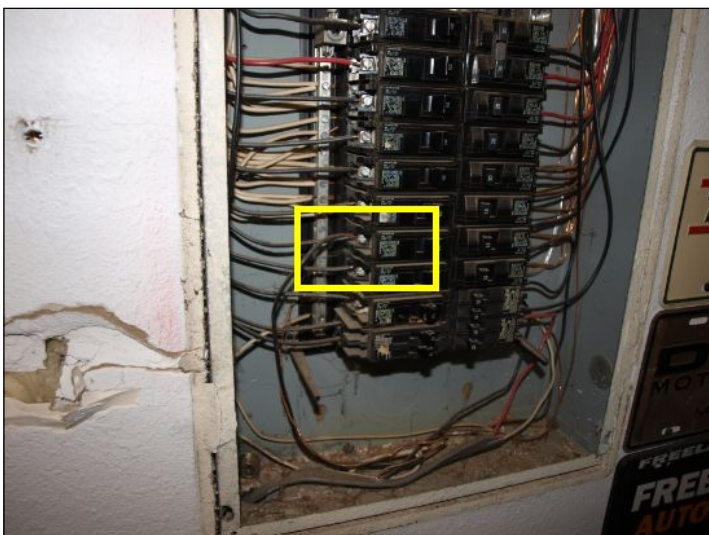
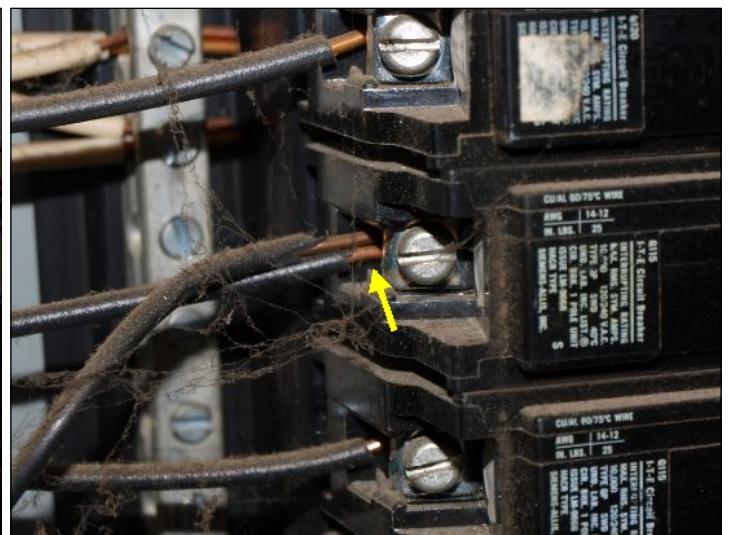
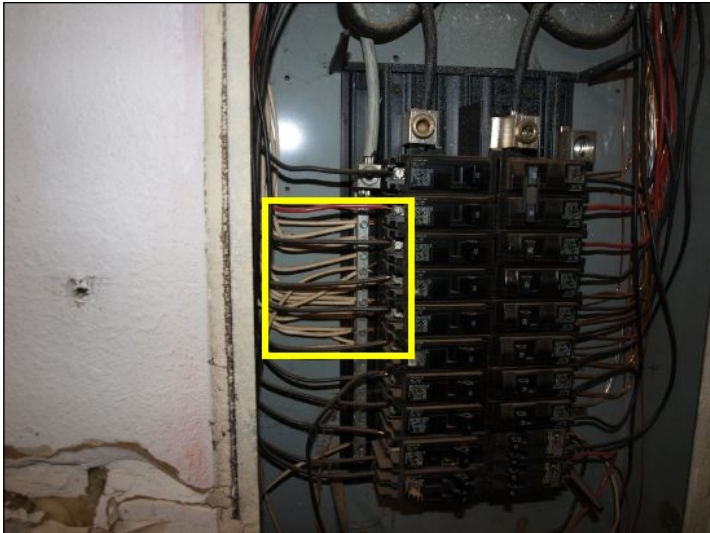
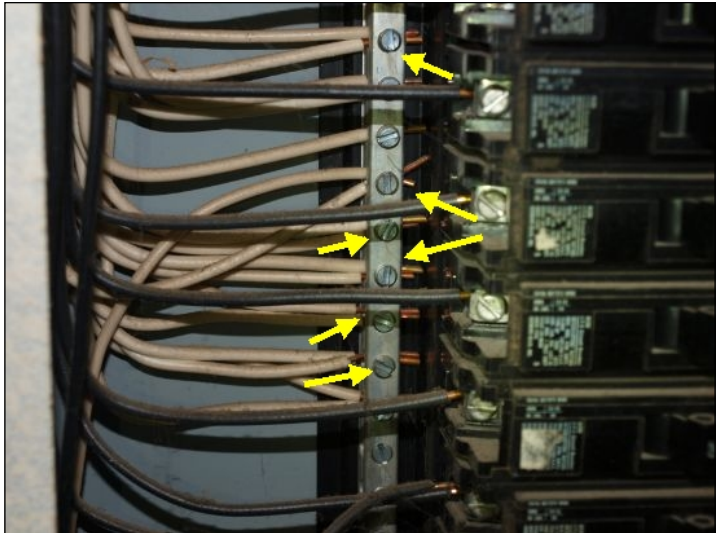
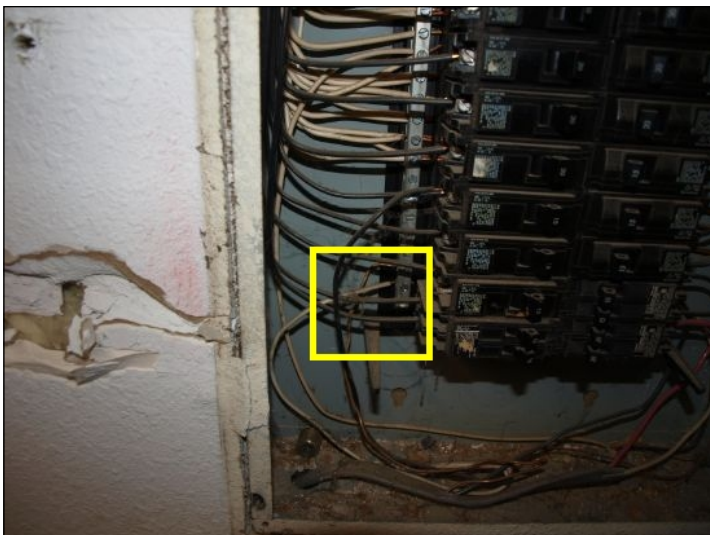
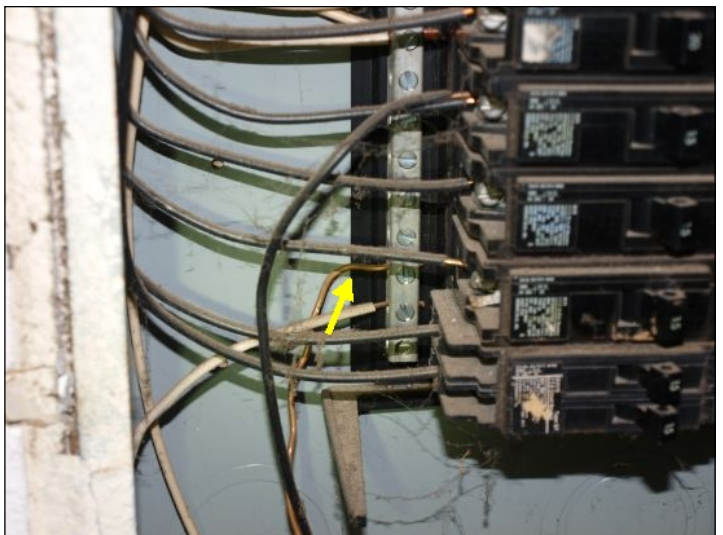
- Observations:
- Panels are without the benefit of complete labeling. This makes it difficult to know what each breaker controls.
 - Multiple wires are connected to a single lug on a circuit breaker where only one wire should be connected.
 - The grounds and neutral lines are on the same buss/terminal bars. As this panel is equipped with sperate bars the lines should be separated, with the neutral bar floating and not bonded to the panel. The grounding bar must be bonded to the panel. This is a safety hazard. A qualified electrician will need to make the needed corrections for increased safety.

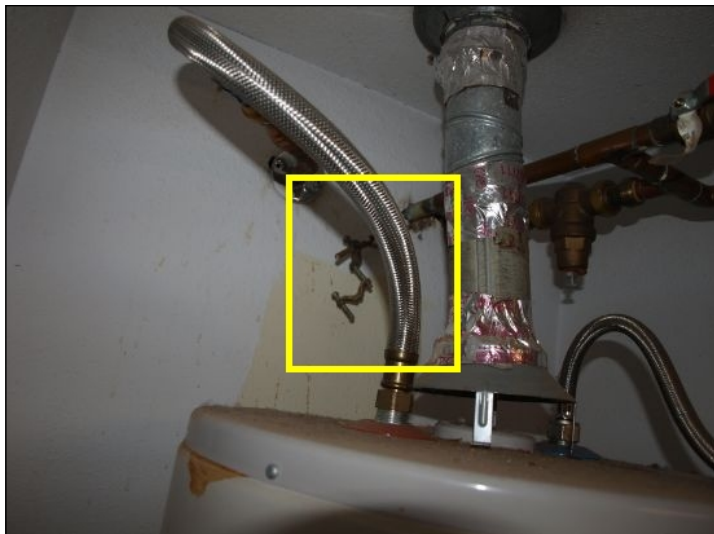
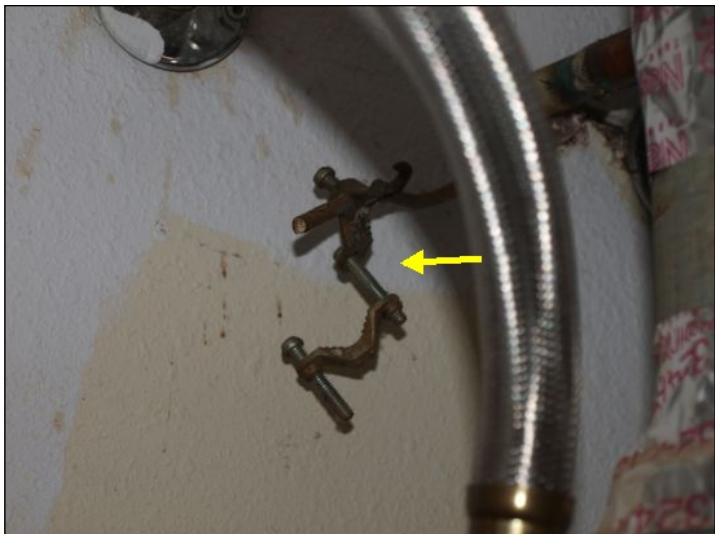
- Loose bonding clamp at water heater. Clamp should be tight and secure. Have the proper repairs made so it is properly attached.

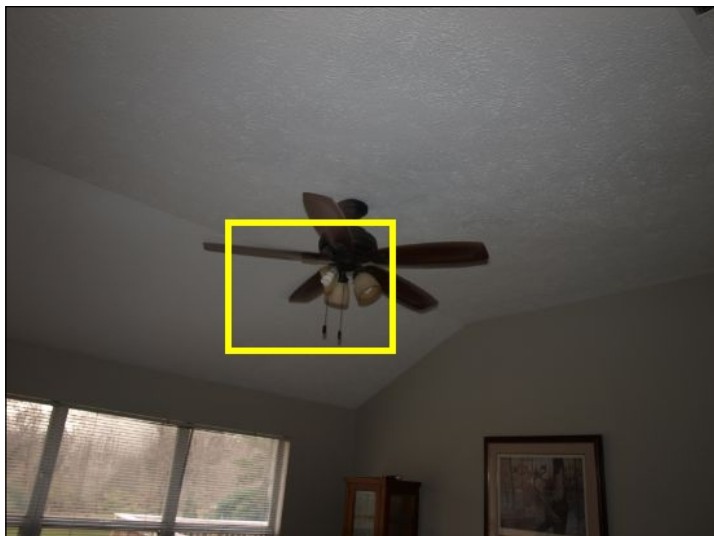
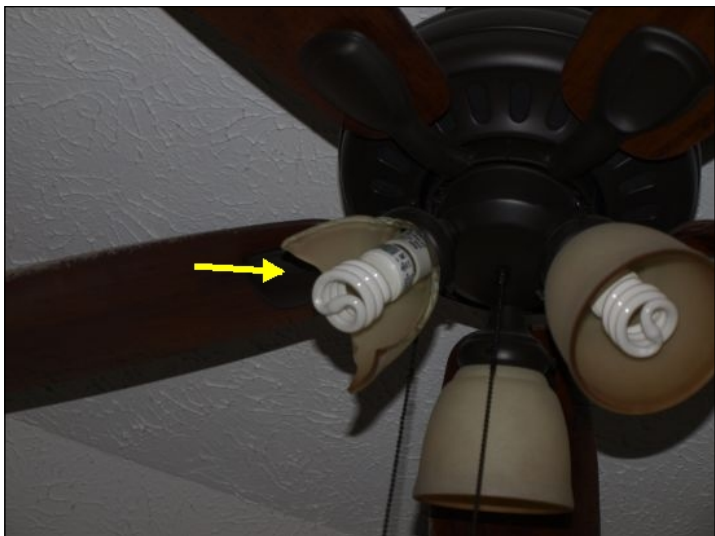
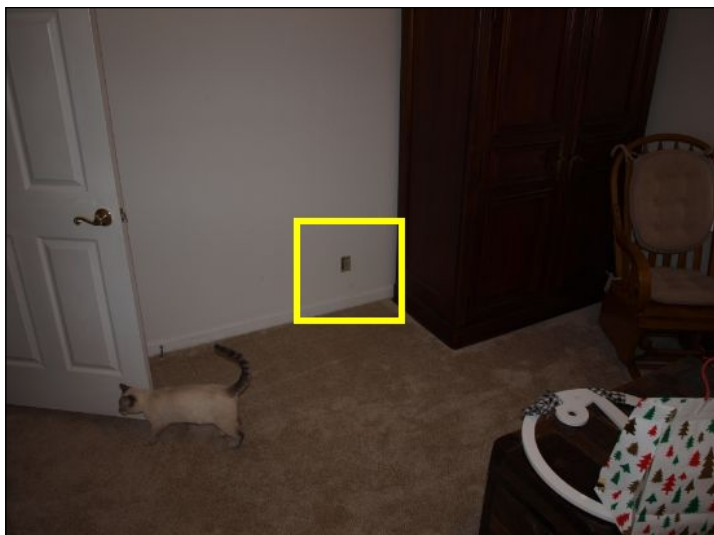
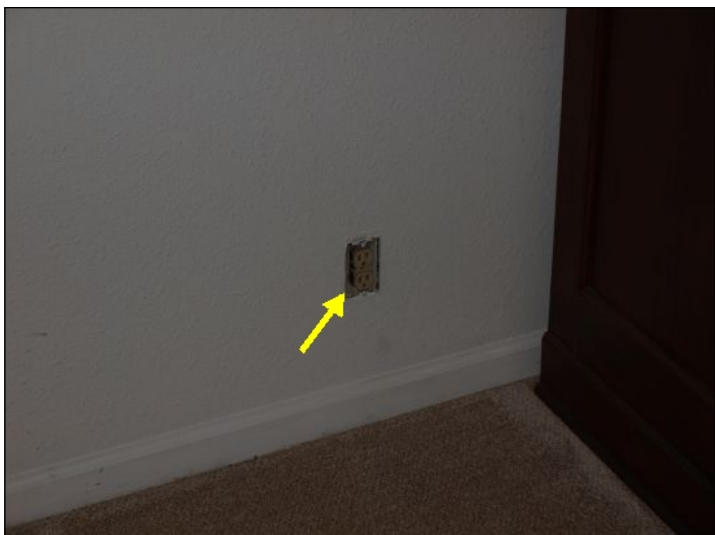
- Missing cover plate viewed in bedroom. Install all cover plates
- Kitchen counter outlets are not **GFCI** protected. For increased safety all kitchen counter and island outlets if present need to be GFCI protected.
- Glass globe on ceiling fan is broken

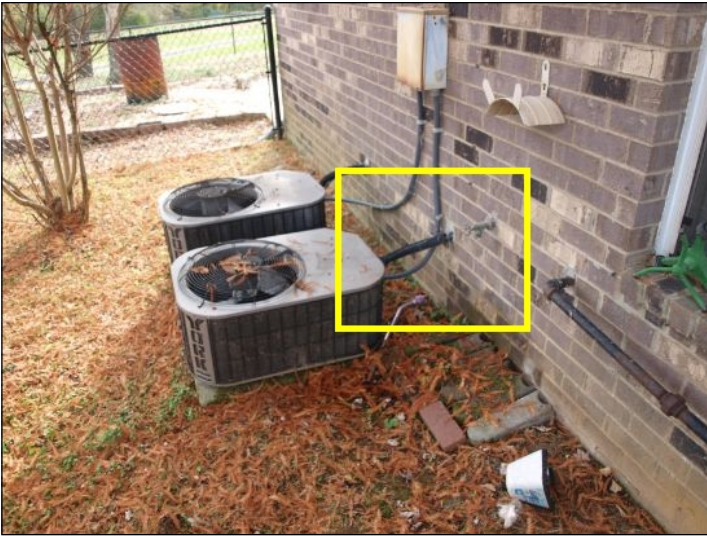
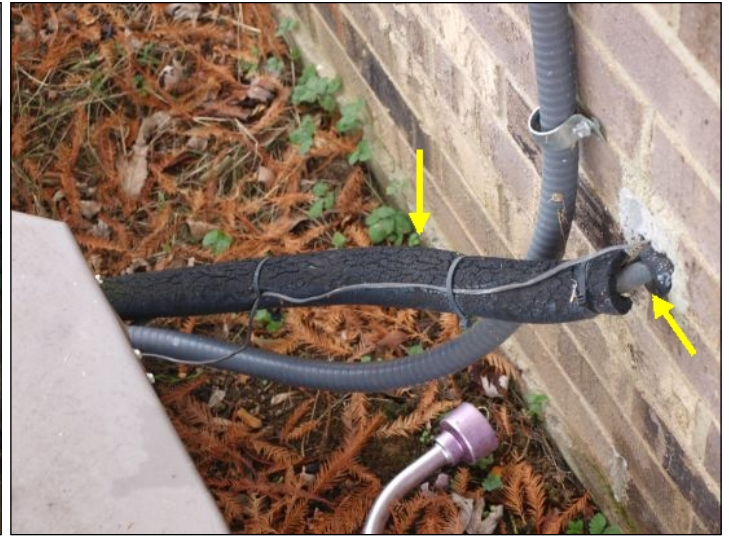
- Systems of this type have an expected life of 10-15 years. Operation over time period should be considered good fortune.
- **The insulation around the refrigerant lines is deteriorated and should be replaced. This is a simple repair but it is important to the proper operation of the system.**

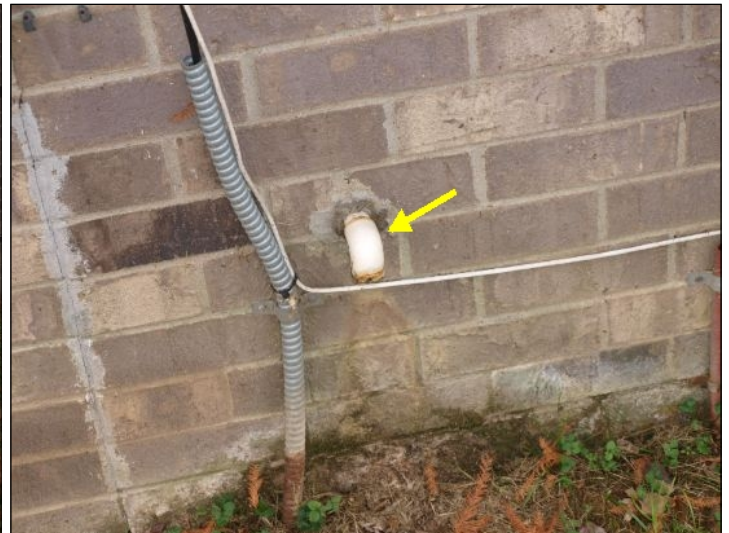
- The end of the condensation line is draining the condensation water by the foundation. It would be advisable to extend the line so it is discharging further away from the foundation.

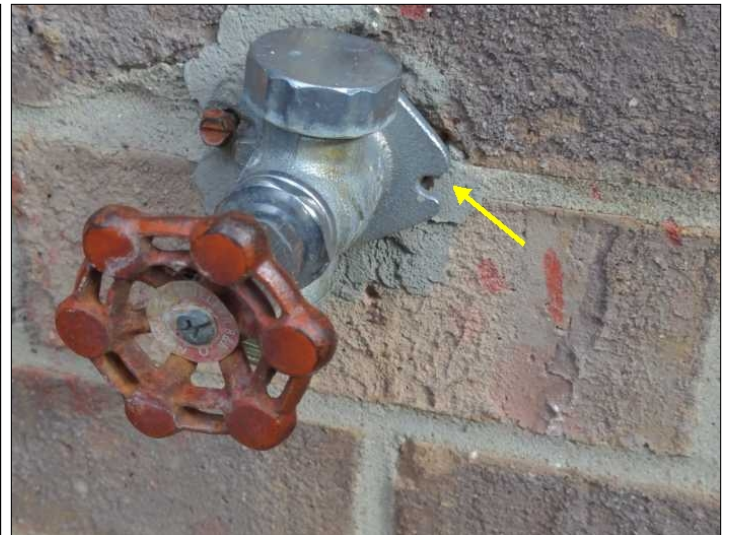
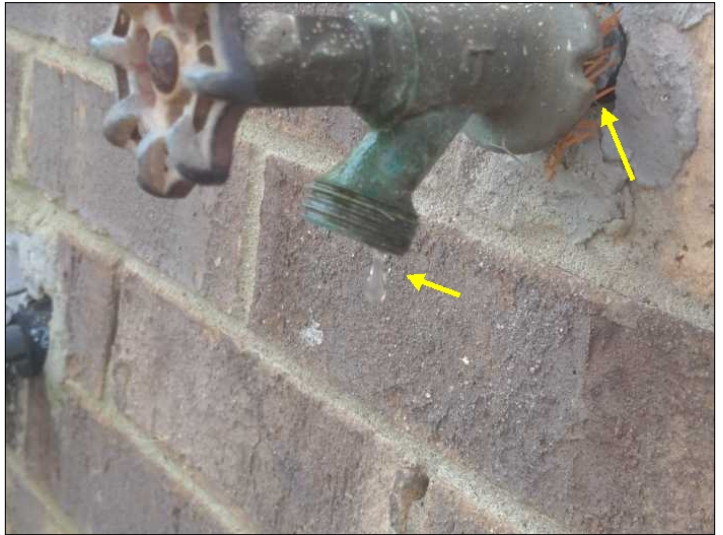
- **Hose bib** was leaking or dripping. Repair as needed.

- The hose bib is not secured to the wall as required. Valves like this must be secured so it does not move as excessive movement of any plumbing fixture can cause leaks.

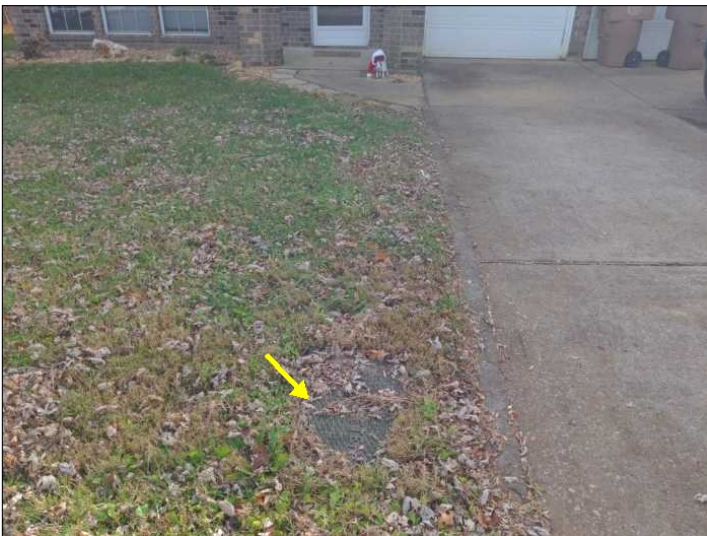
Water meter

- Gas meter appears serviceable
- Standing water viewed in water meter box. I could not tell 100% if this was due to groundwater or a leak at the meter. The utility company should be contacted to confirm that the meter and lines in the box are in good condition.

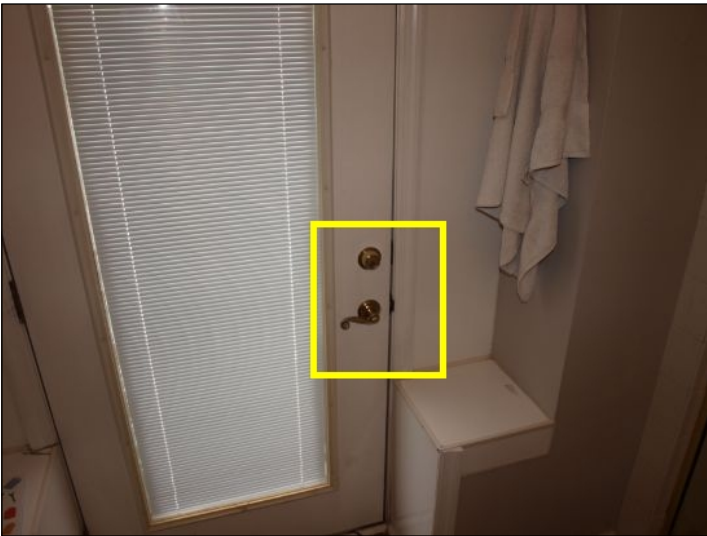
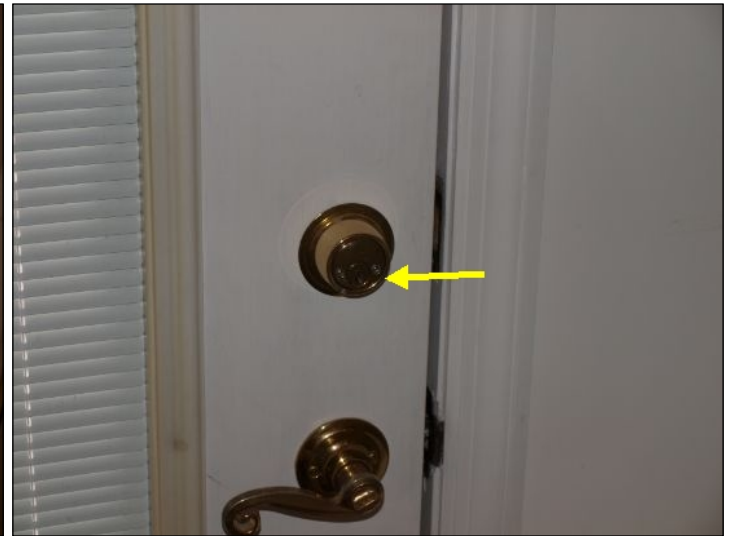
- Keyed deadbolt on entry/exit doors should be replaced with a thumb latch deadbolt. In the event of an emergency and the key is not in a keyed lock, you can not open the door. Upstairs deck

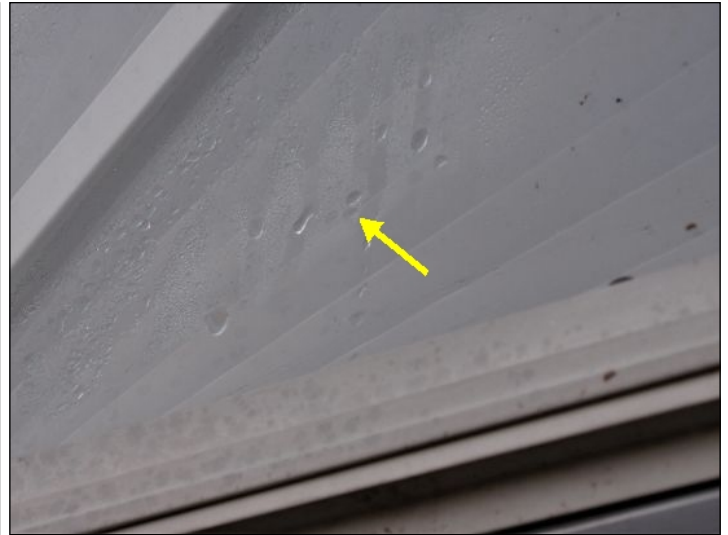
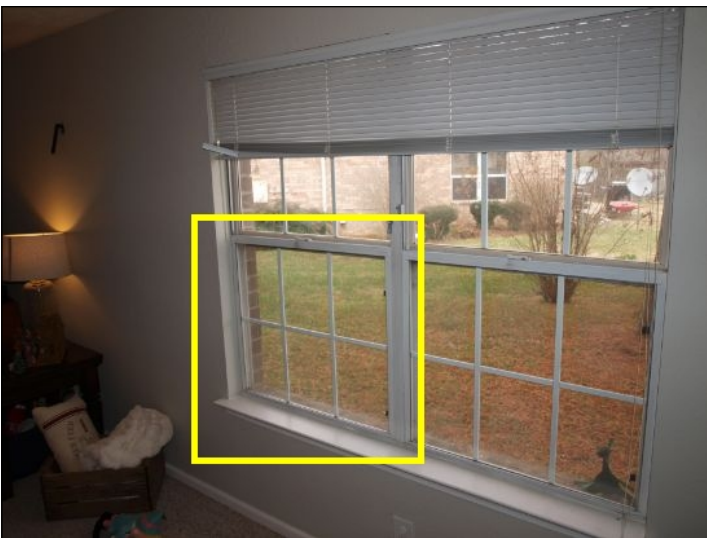
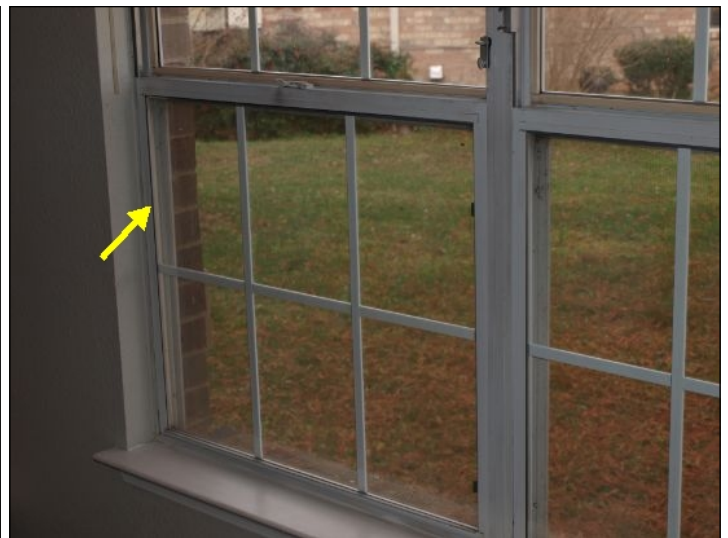
- Frosted window(s) found. This is an indication that the thermal seal of the insulated window has been compromised and moisture is now collecting between two panes of glass. Replacement of the window is the only way to correct this. It is very likely that additional windows could have failed seals but they have not fogged yet.
- Many of the windows are not working properly. All windows should open under normal force and remain open, a young child should be able to open a window. Have all windows made to open properly without excessive force and remain in the open position.

Would not open

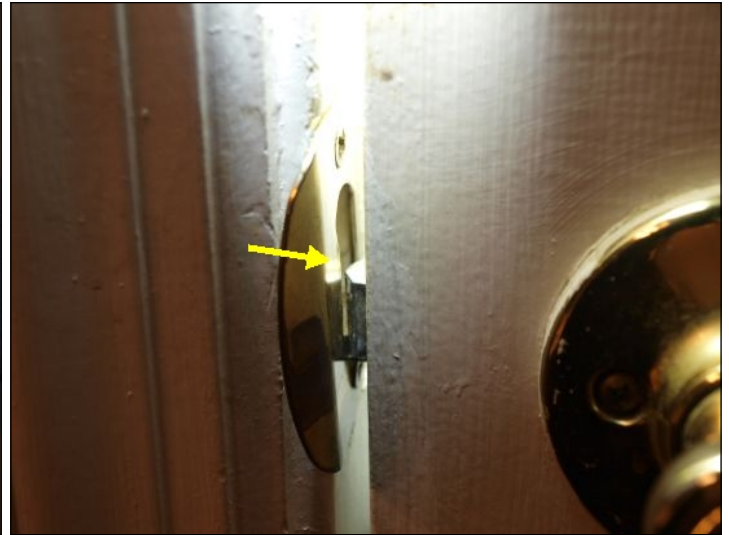
- Adjustments needed, door does not latch properly

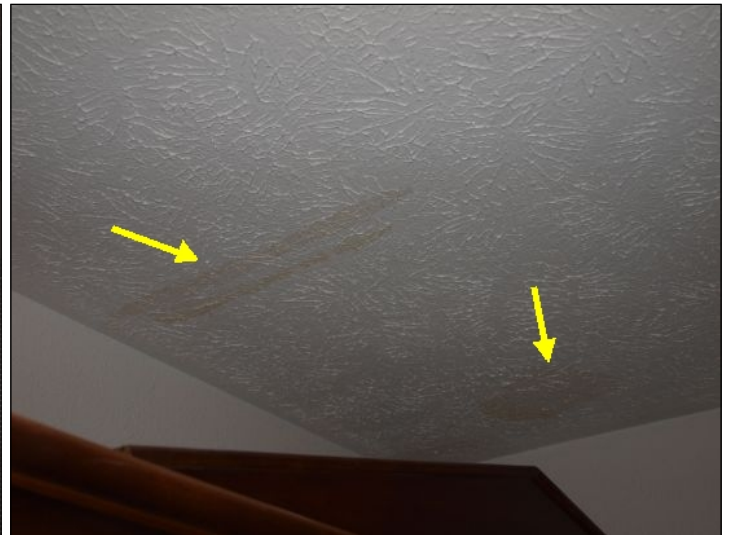
- Stains noted from previous leaks. They tested dry. Consult with owners.

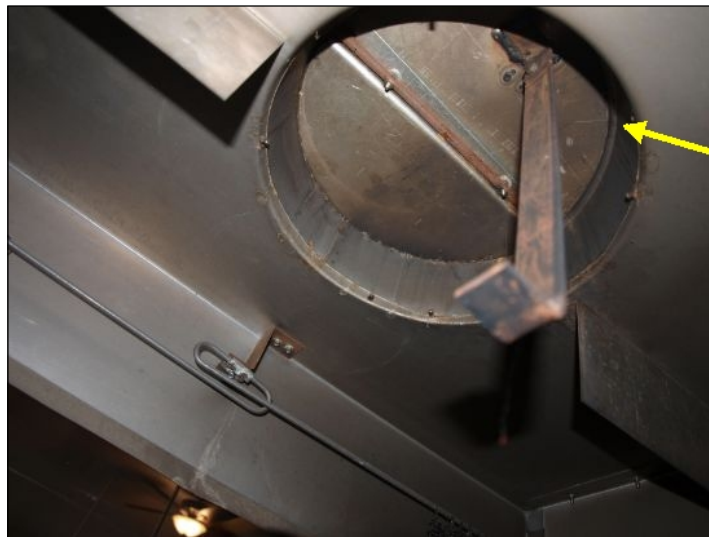
- With gas logs the damper should be held in the open position with a simple damper locking device. This prevents the damper from completely closing.

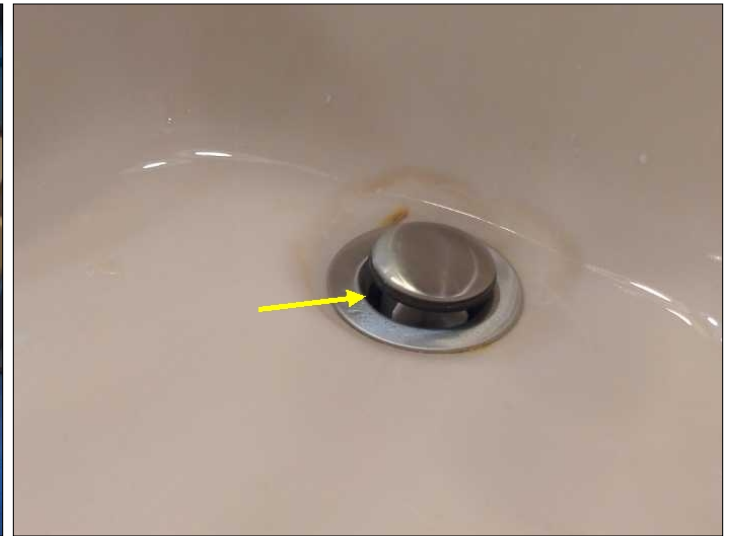
- Stopper is not working properly. Repair as needed so it goes up and down with the pull/push lever.

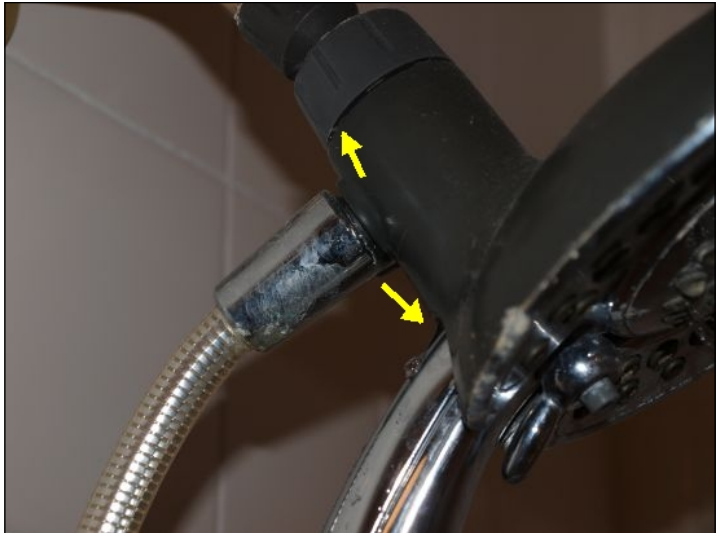
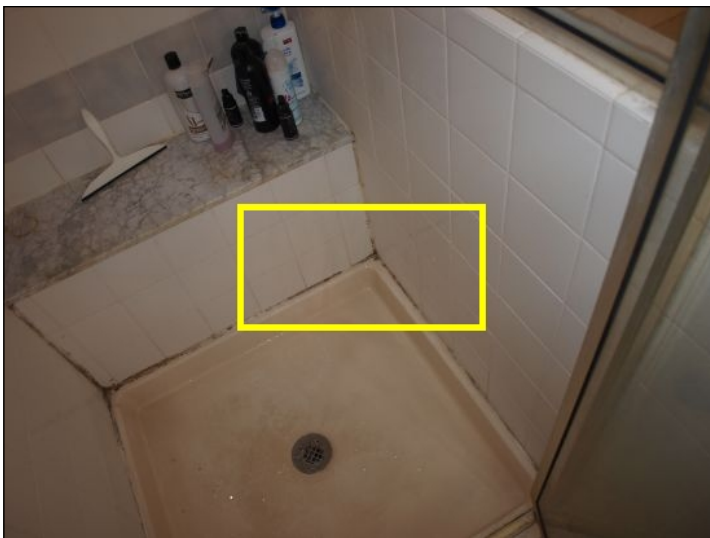
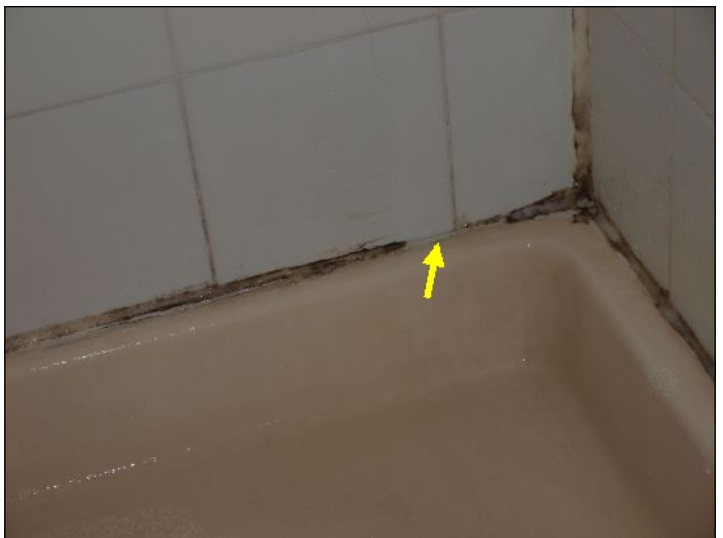
- Regrouting of the tile is needed.
- Showerhead is leaking

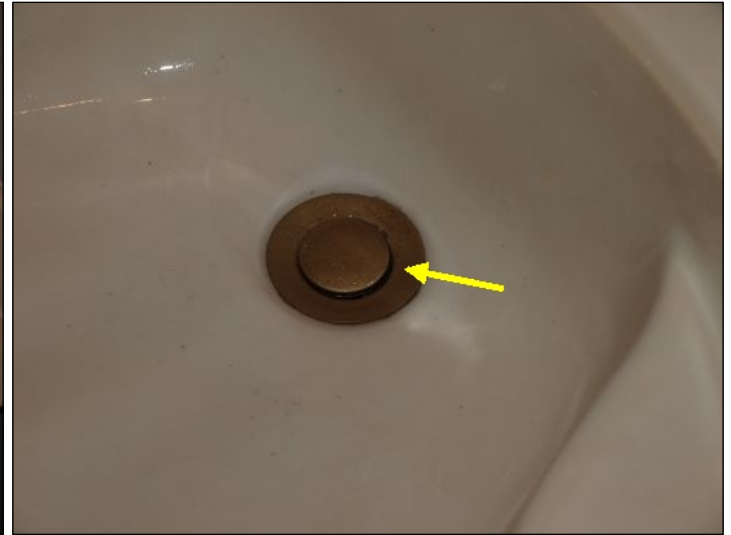
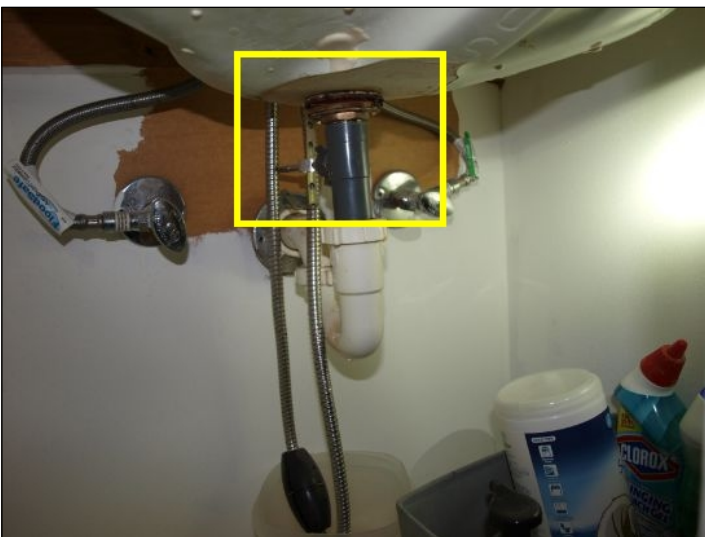
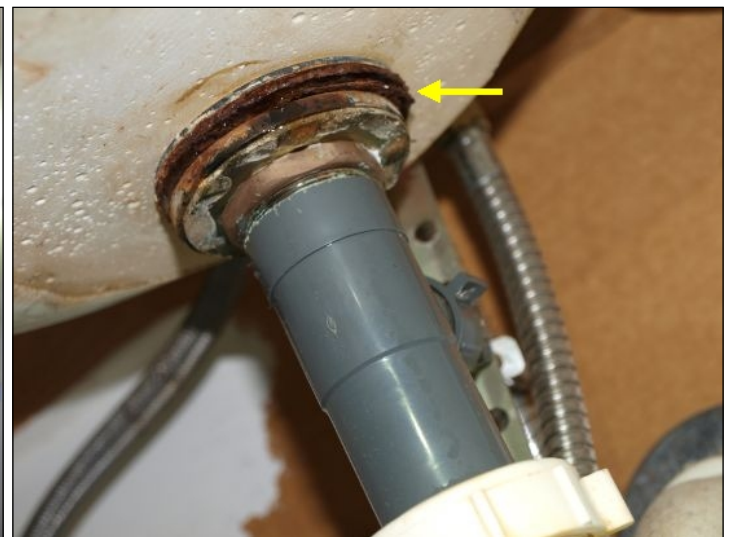
- Leak under sink at drain line, connection at tail piece.
- Stopper is not working properly. Repair as needed so it goes up and down with the pull/push lever.

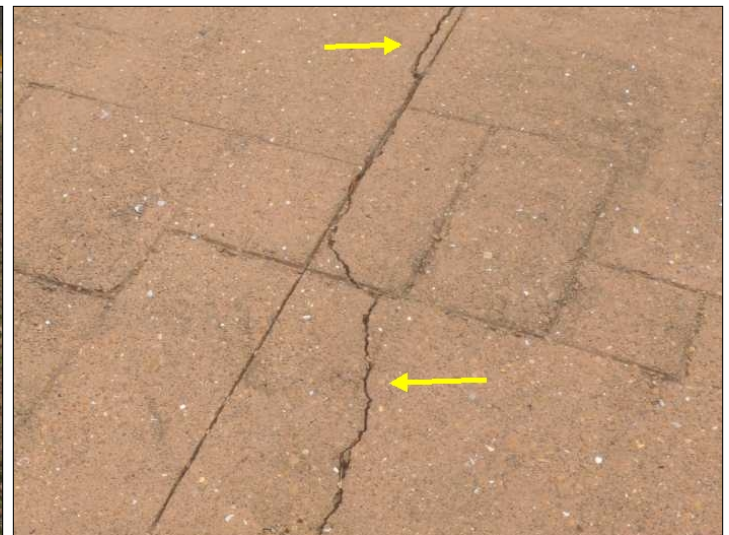
- **Patio slab is broken/cracked. You should consider sealing the cracks to help prevent water from entering and causing additional issues.**
