Trace Inspections

Property Location: 189 Sleigh Bells Court Nashville TN 37013

INSPECTION REPORT

Date of Inspection: 12/1/2021

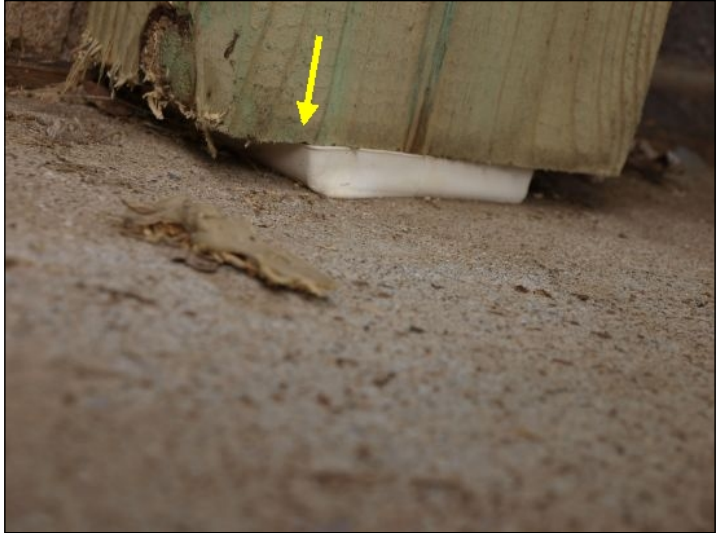
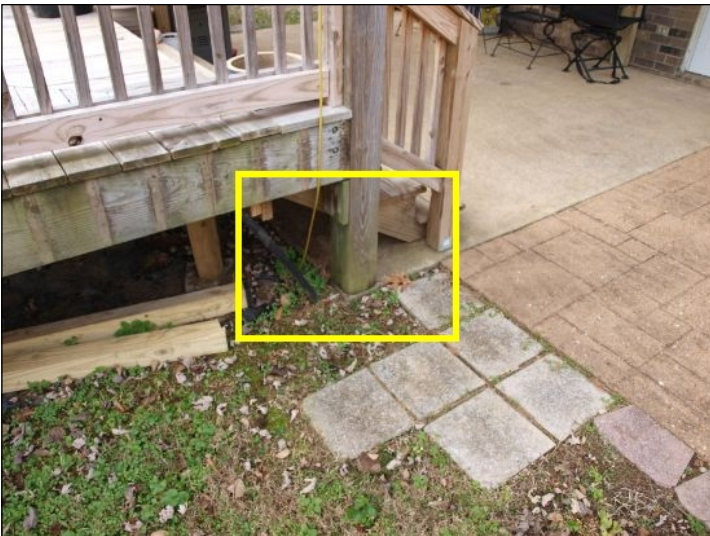
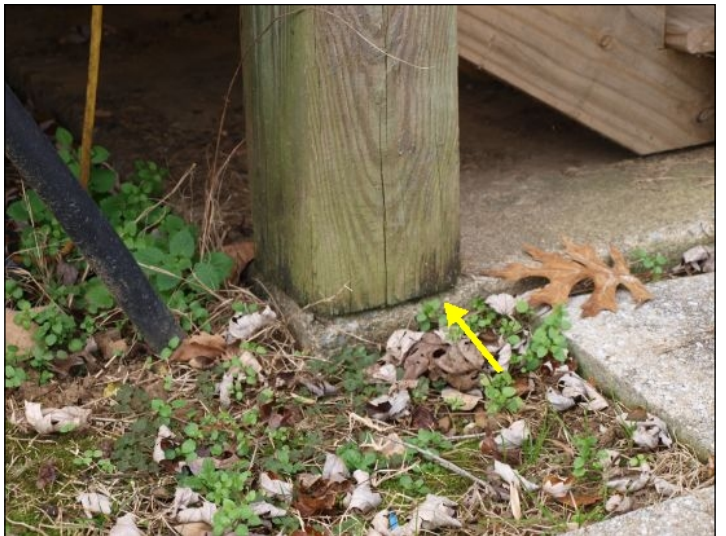
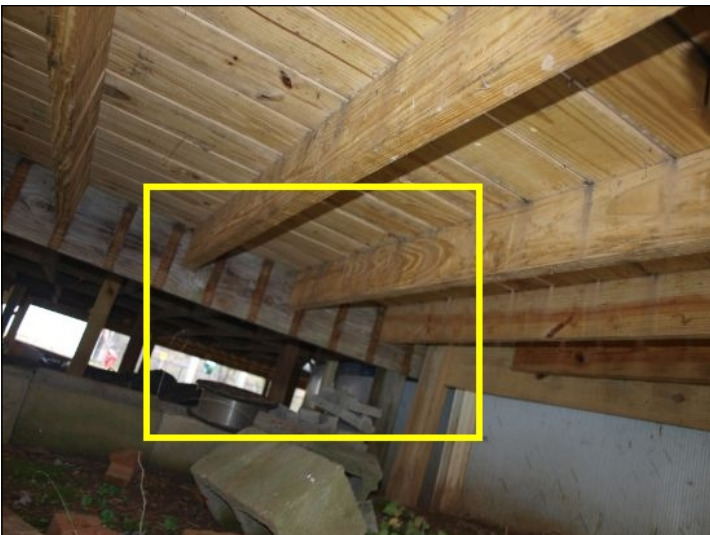
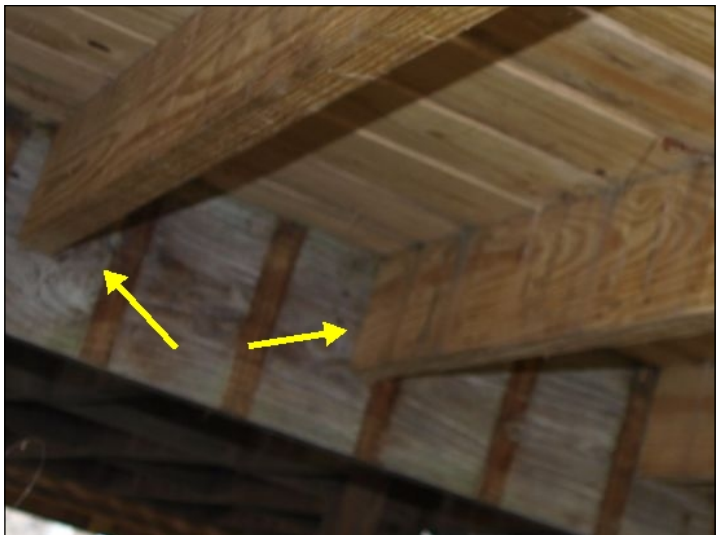
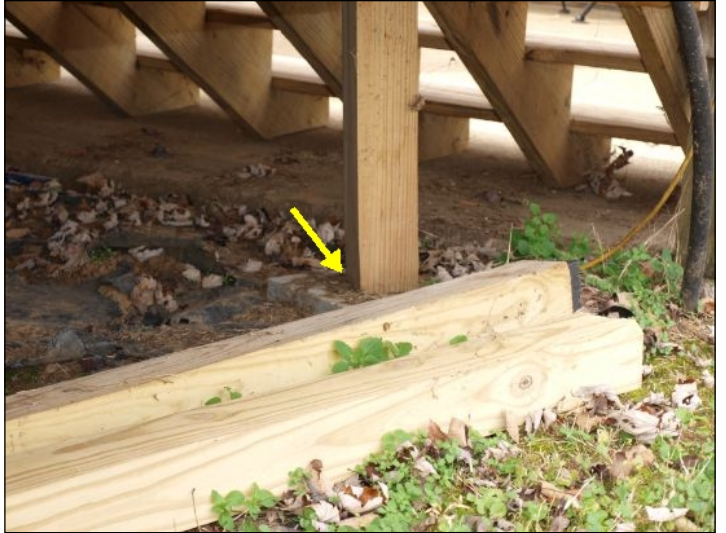
- **Railings are not secure, they move when pushed upon. Have all railings properly repaired so they do not move and meet current guidelines.**
- **The deck is not supported properly, the supporting posts are not secured to the concrete below**
- **The deck has been built with no deck hangers or ledger board. They are used to support the joist and should be added for increased safety.**
