Trace Inspections

Property Location: 189 Sleigh Bells Court Nashville TN 37013

INSPECTION REPORT

Date of Inspection: 12/1/2021

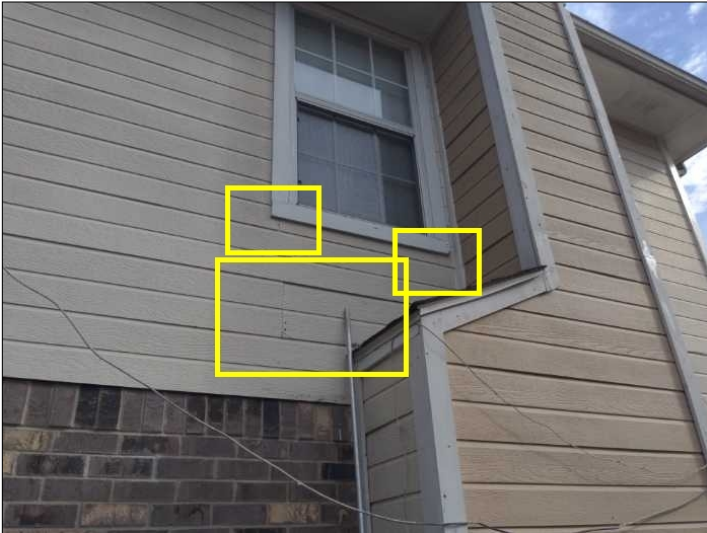
CLADDING CONDITION

- Cracking and exposed nails in cladding on right side of home

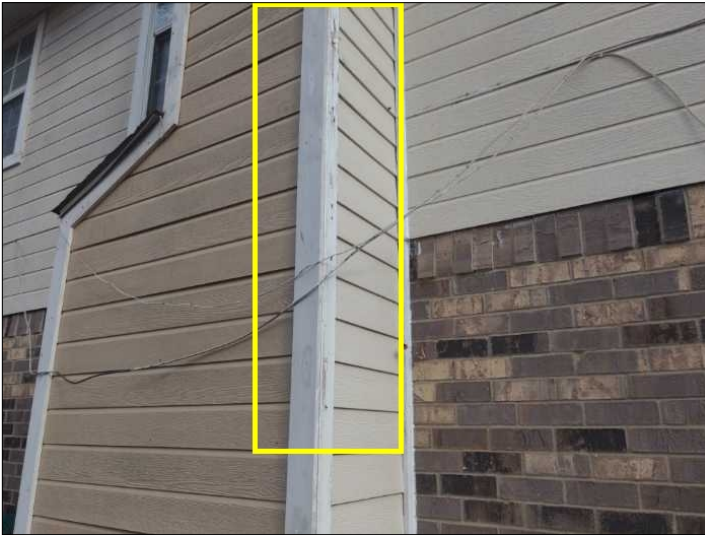
TRIM

- The wood trim around several of the windows is rotting. All rotted wood should be properly replaced, this might even involve replacement of the entire window and frame.
- The trim at the base of the door is rotting and should be repaired.
- The wood trim is in need of paint. Paint helps to protect and extend the life of the wood.

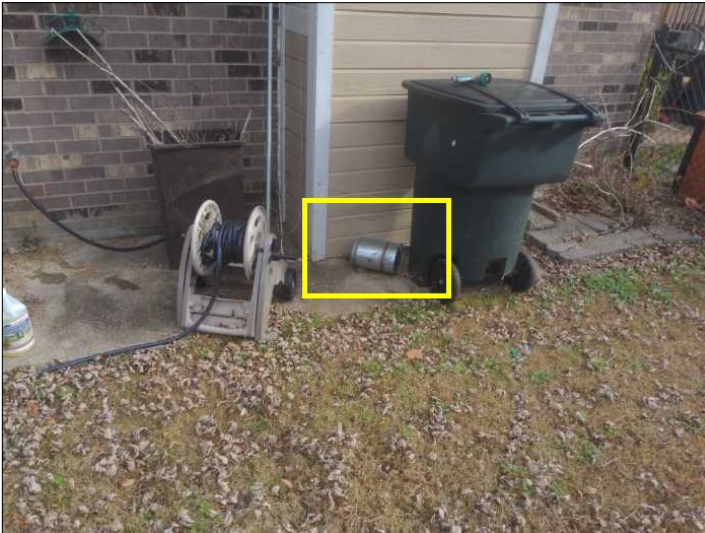
CHIMNEY

- The cladding does not have enough clearance between its base and the ground or grade. With wood siding we want to see around 6" to 8" of clearance and other types of cladding around 4". You should lower the bedding material or dirt or have the siding raised so that it is a minimum of 4" above the grade (ground).
- Moisture damaged cladding viewed on chimney chase.

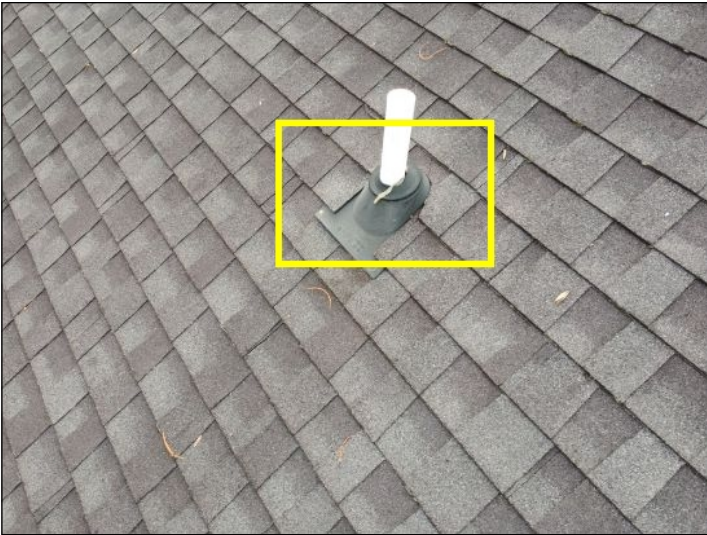
- The rubber boots around the vent stacks are cracking and need replacing. Recommend replacing all vent boots with new ones. Vent boots have a short life span of 5-7 years before they need to be replaced. Have a qualified roofing contractor make the needed repairs.

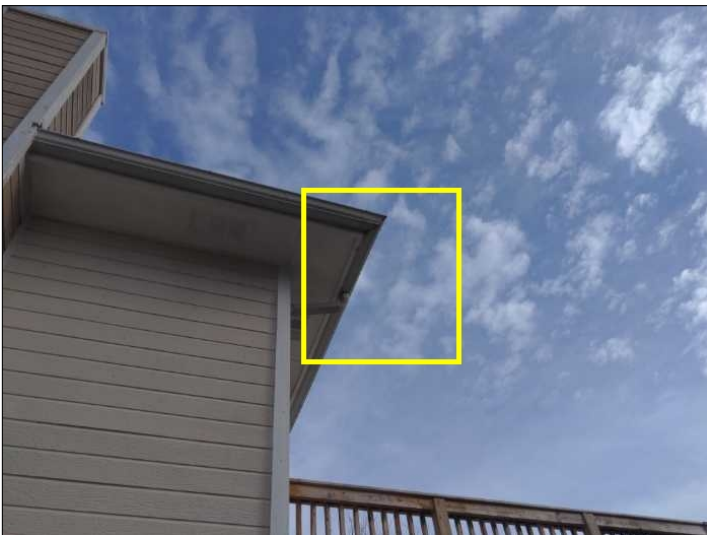
RAIN GUTTERS AND DOWNSPOUTS CONDITION

- Subsurface drains noted but they were not tested for blockages or proper drainage as this is outside the scope of a home inspection.
- Debris (sticks, dead leaves, etc.) in gutter, gutters need to be cleaned.
- The old "gutter nails" are pulling out from the fascia boards and this can cause the gutters to sag and not drain properly. Have the proper repairs made by a gutter contractor or roofing contractor that works on gutters.

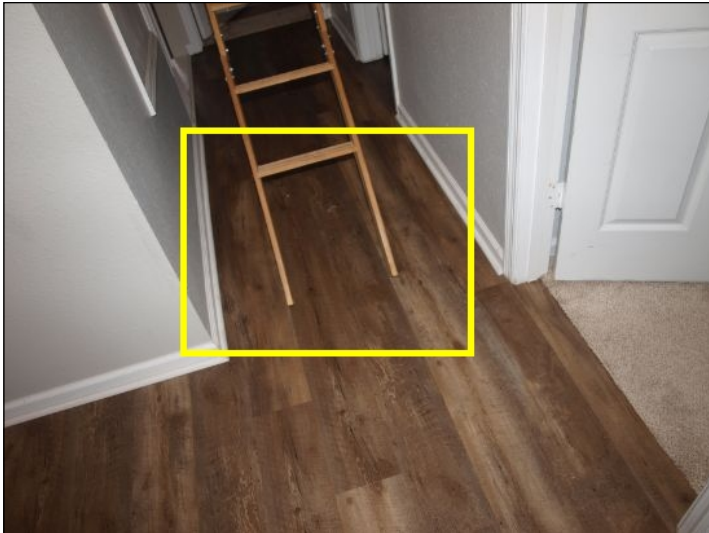
ATTIC CONDITIONS

- Pull down stairs were never cut to the correct length so they will sit flush with the floor.

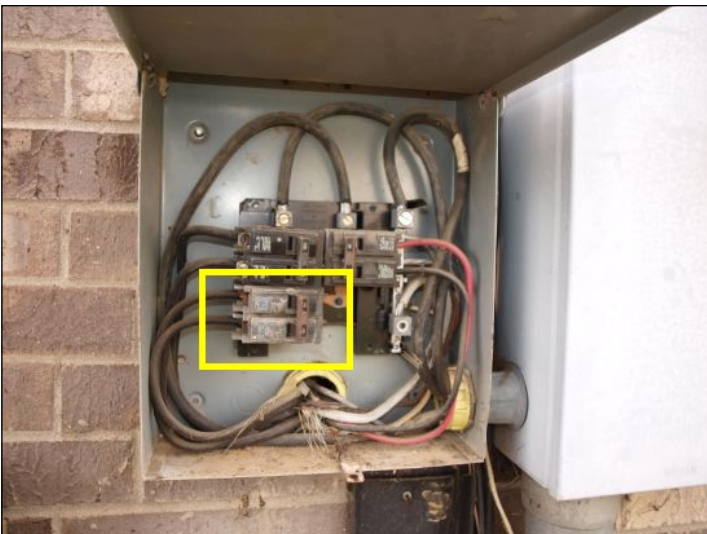
SERVICE PANEL CONDITION

- Corrosion is noted within the electrical panel. This is an indication of an aged panel and is due to exposure to the elements.

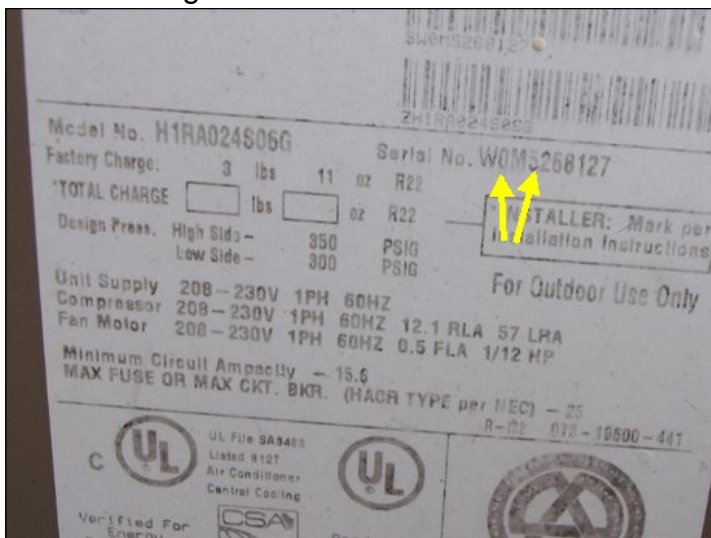
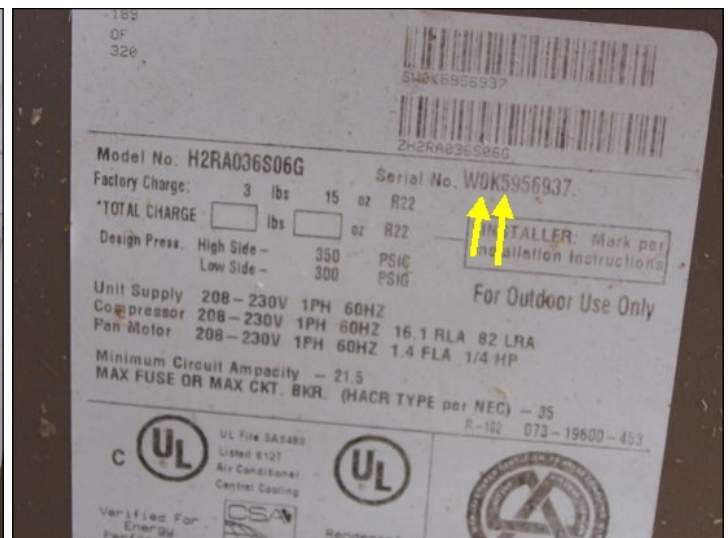
HVAC OVERALL CONDITION

- Systems of this type have an expected life of 10-15 years. Operation over time period should be considered good fortune. Both units are 2005 models.

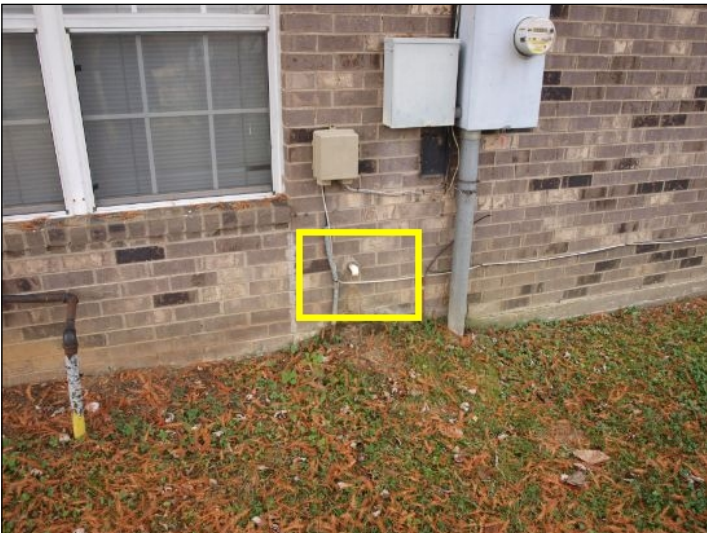
- The end of the condensation line is draining the condensation water by the foundation. It would be advisable to extend the line so it is discharging further away from the foundation.

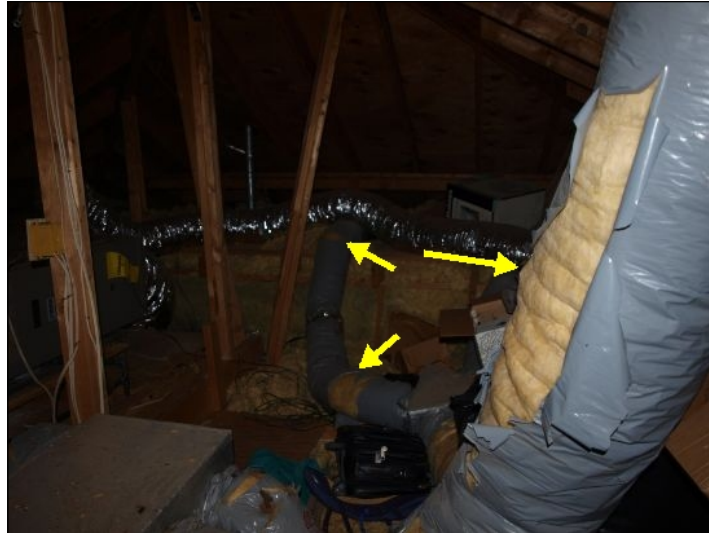
AIR DUCT CONDITION

- The air duct cover has split open exposing the insulation. The only way to properly repair is to replace the flexduct. This is a common issue with flexduct of this age and type.

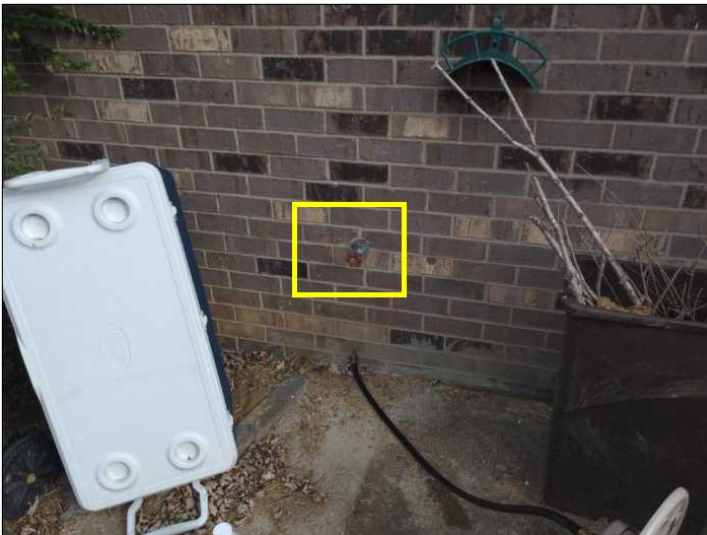
- **Hose bib** was leaking or dripping. Repair as needed.

- The hose bib is not secured to the wall as required. Valves like this must be secured so it does not move as excessive movement of any plumbing fixture can cause leaks.

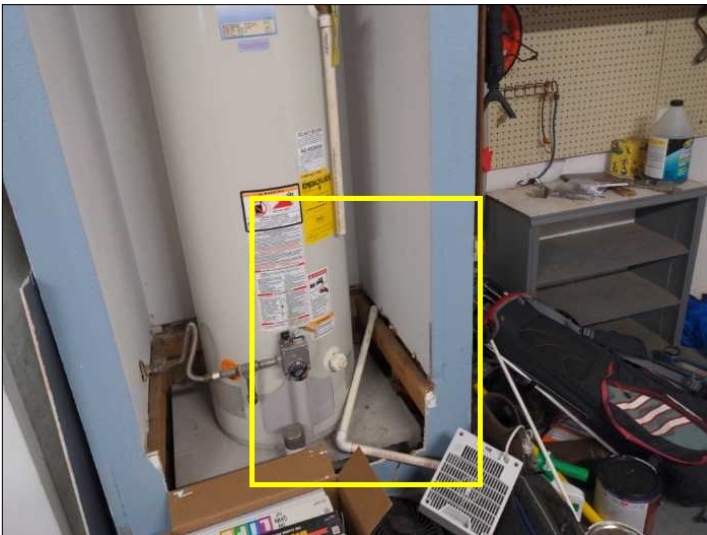
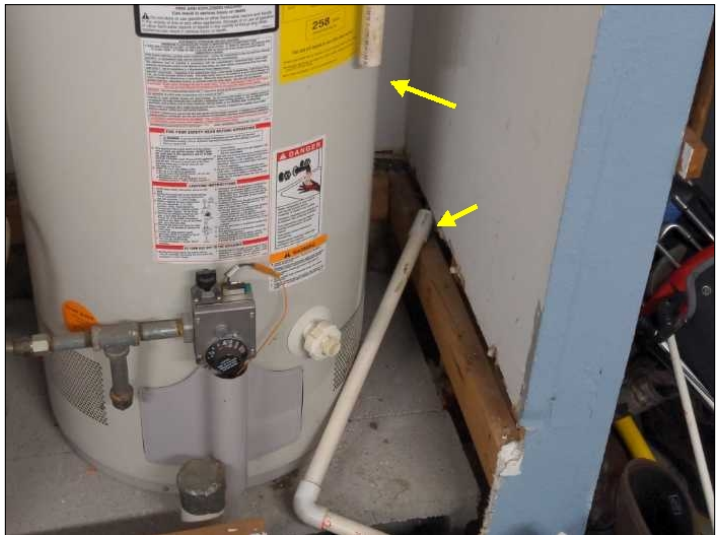
WATER HEATER 1 CONDITION

- **IPR** line is disconnected
- The water heater flue pipe is not connected to the top of the water heater properly. Flue gases are potentially escaping into the area and not out the flue pipe.

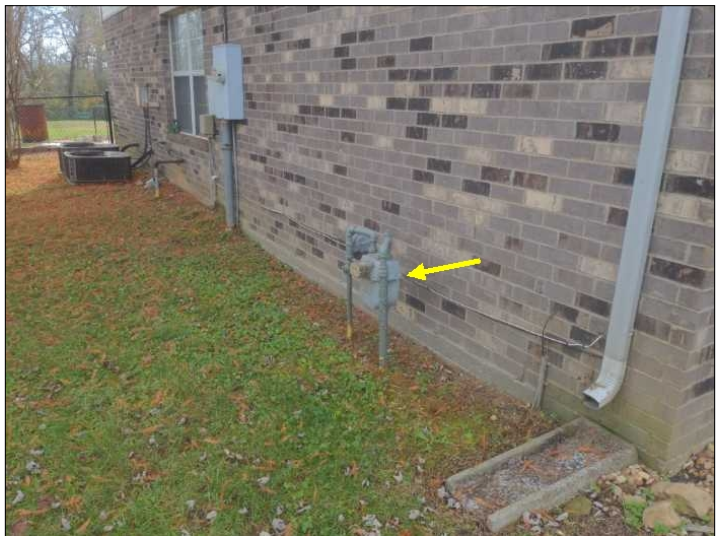
Water meter

- Gas meter appears serviceable
- Standing water viewed in water meter box. I could not tell 100% if this was due to groundwater or a leak at the meter. The utility company should be contacted to confirm that the meter and lines in the box are in good condition.

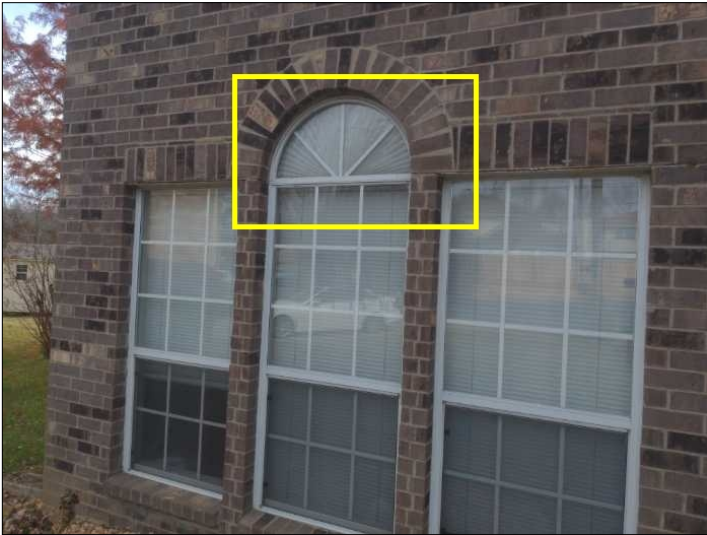
- Frosted window(s) found. This is an indication that the thermal seal of the insulated window has been compromised and moisture is now collecting between two panes of glass. Replacement of the window is the only way to correct this. It is very likely that additional windows could have failed seals but they have not fogged yet.
- Many of the windows are not working properly. All windows should open under normal force and remain open, a young child should be able to open a window. Have all windows made to open properly without excessive force and remain in the open position.

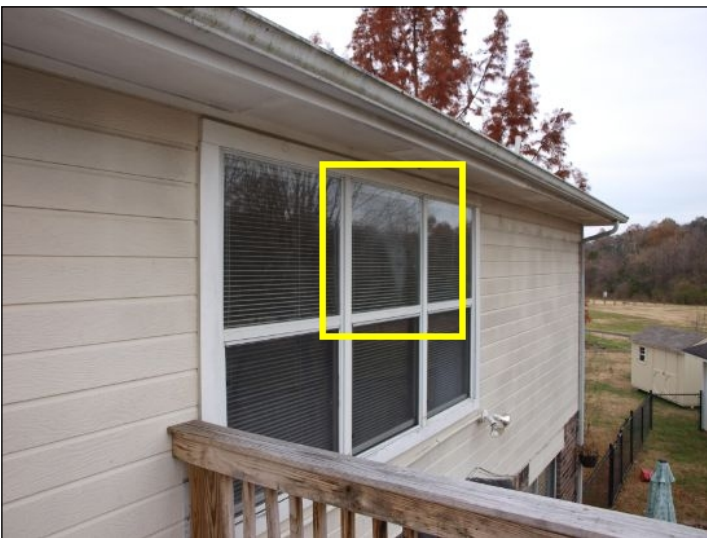
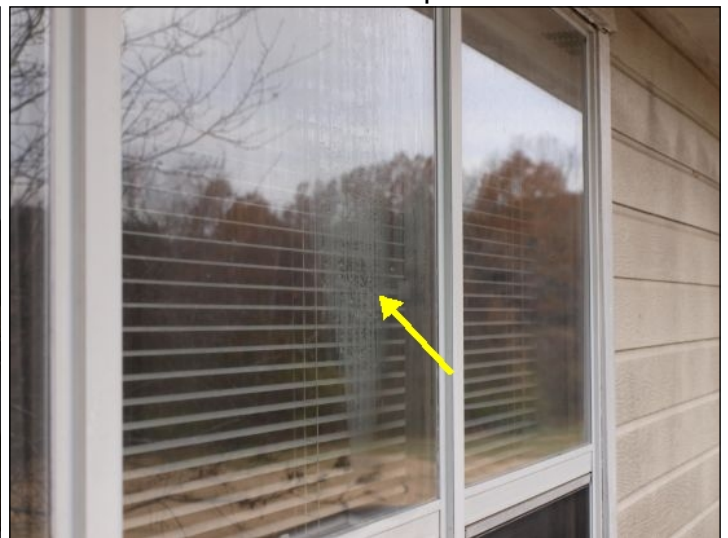
Would not open

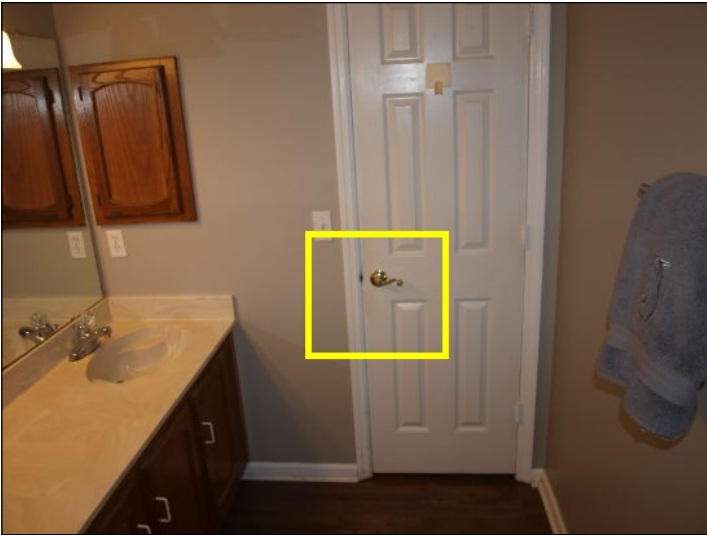
INTERIOR DOORS

- Adjustments needed, door does not latch properly

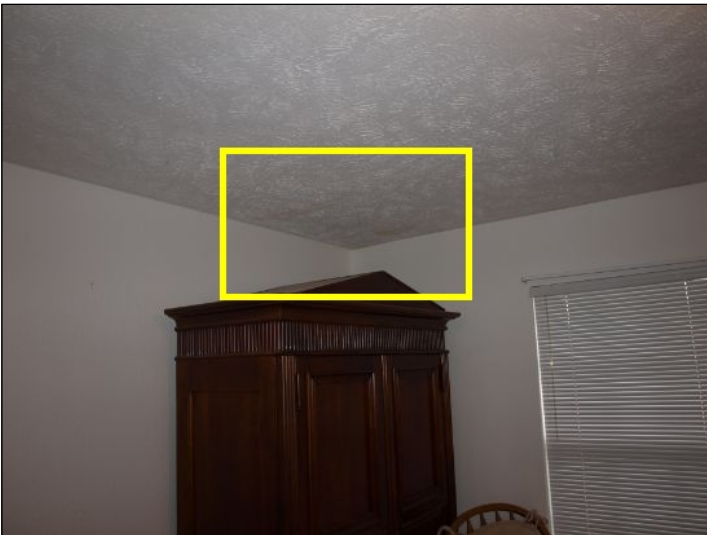
CEILING CONDITION

- Stains noted from previous leaks. They tested dry. Consult with owners.

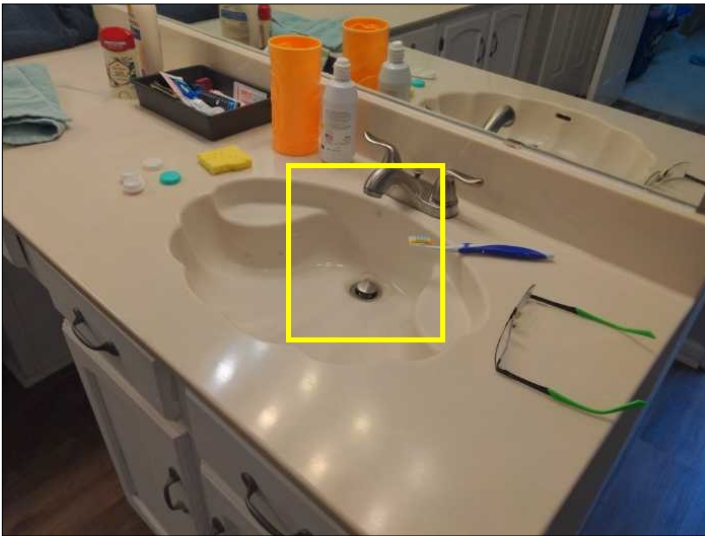
- Stopper is not working properly. Repair as needed so it goes up and down with the pull/push lever.

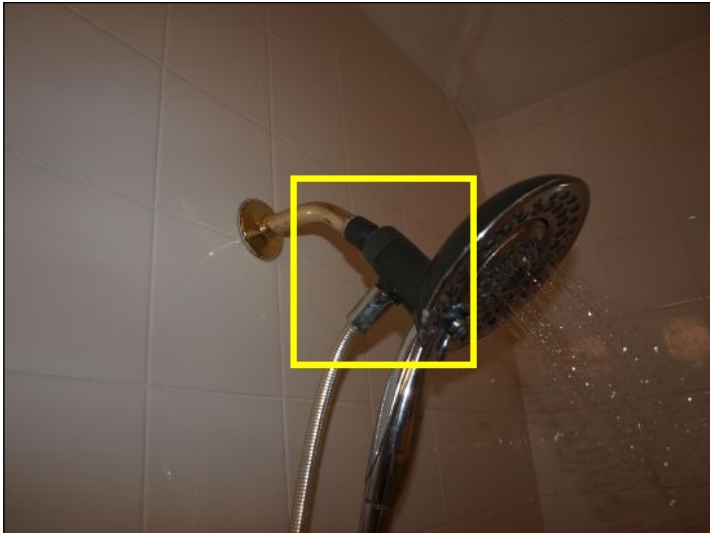
- Regrouting of the tile is needed.
- Showerhead is leaking

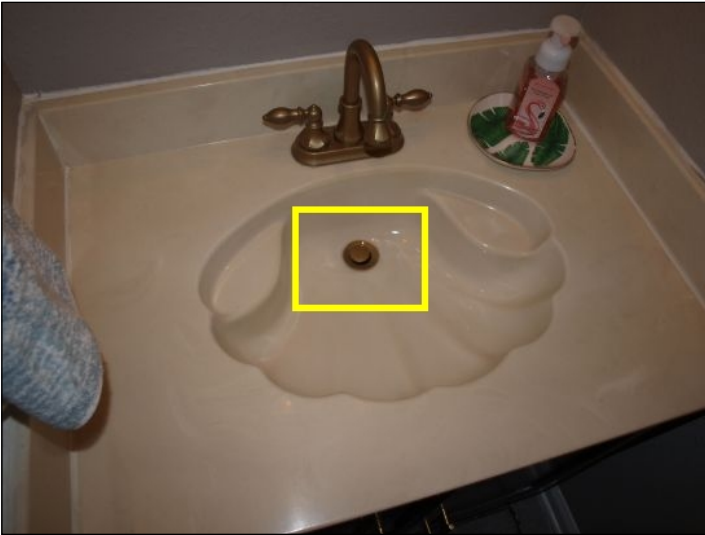
- Leak under sink at drain line, connection at tail piece.
- Stopper is not working properly. Repair as needed so it goes up and down with the pull/push lever.

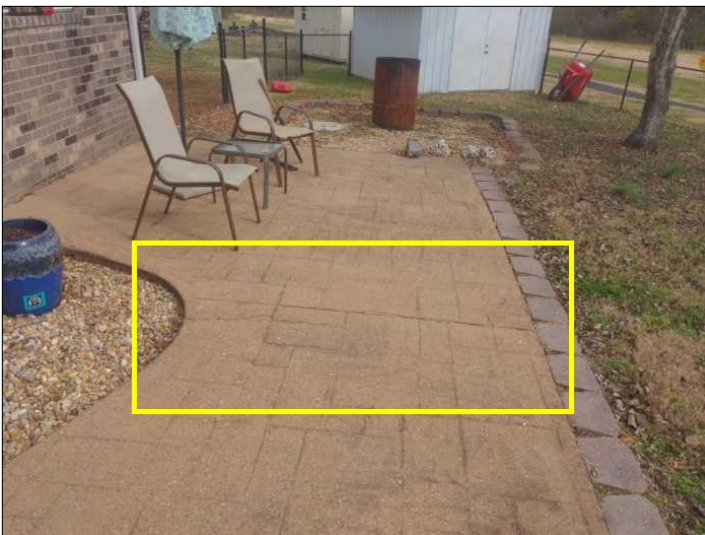
- **Patio slab is broken/cracked. You should consider sealing the cracks to help prevent water from entering and causing additional issues.**
